Urban Model Corridors (Pilot districts -Indore, Dhar & Datia)

Draft Environment and Social Management Plan

Madhya Pradesh Rural Road Development Authority

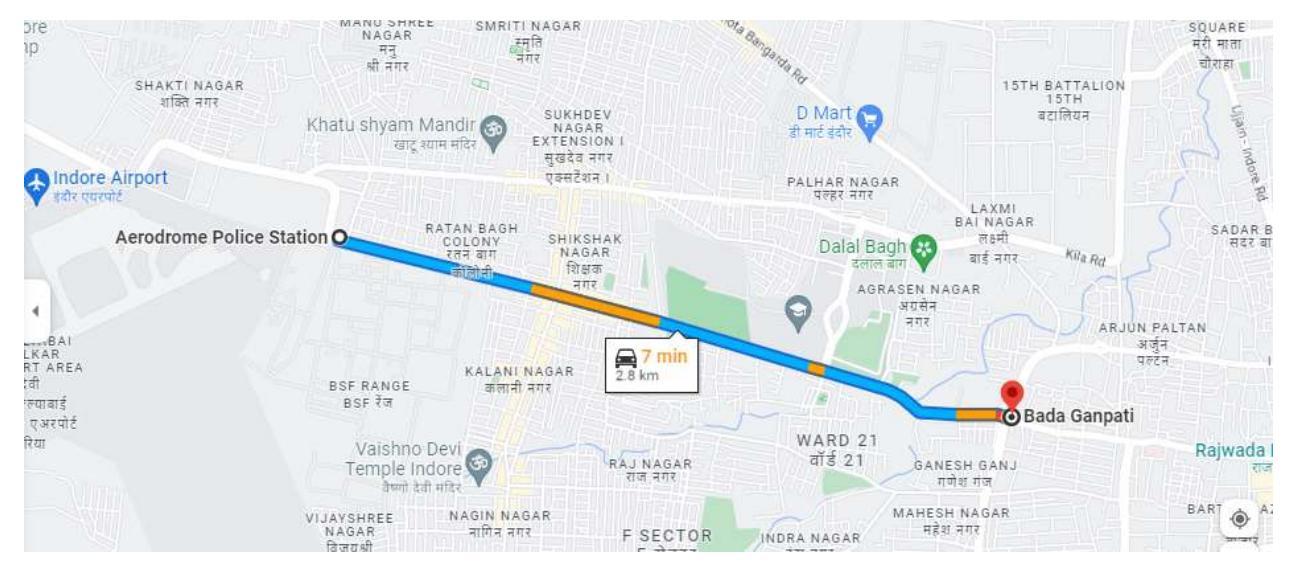
Figure 1: Alignment of the selected Urban Corridor in Indore

Currently, it is a four-lane divided carriageway with mix of paved and earthen shoulder on either side. The width of shoulder varies across the stretch. There is also paver block footpath at across the left-hand side of the junction. There are drain openings present on the junction of footpath and shoulder.

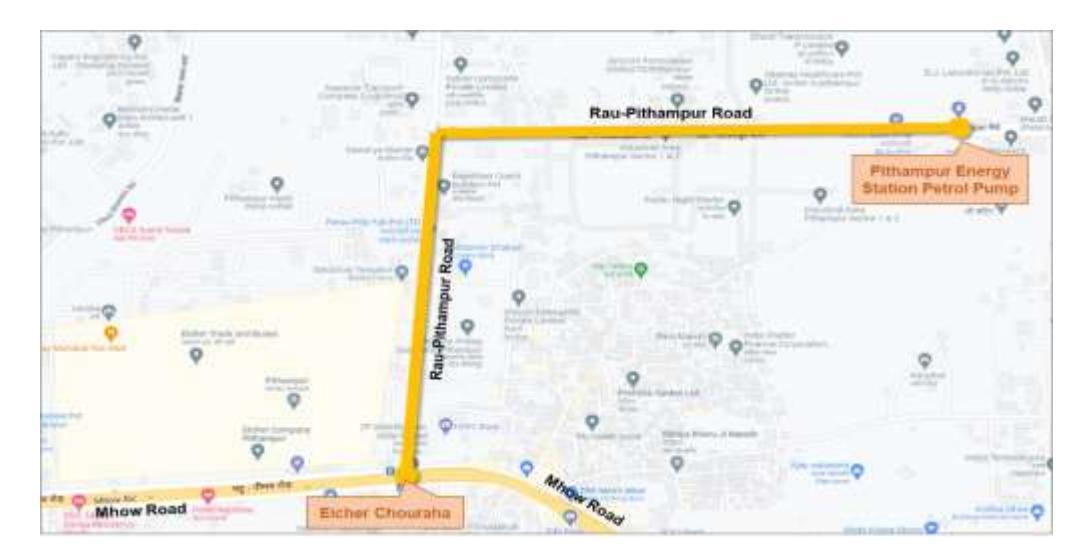
Figure 2: Alignment of the selected Urban Corridor in Dhar

The selected stretch is of 1.5 Km length starting at Eicher Chowraha near Pithampur Industrial Area and ending at Rau-Pithampur Road in the district of Dhar. The road starts near Eicher Chowraha Pithampur bus stand and ends near Pithampur Energy Station petrol pump on Rau-Pithampur Road. The predominant land use along the stretch is industrial, with presence of small shops and fruits and vegetable vendors. The traffic on this road comprises of motorized and non-motorized traffic, with a large chunk of traffic comprising of employees of Eicher factory.

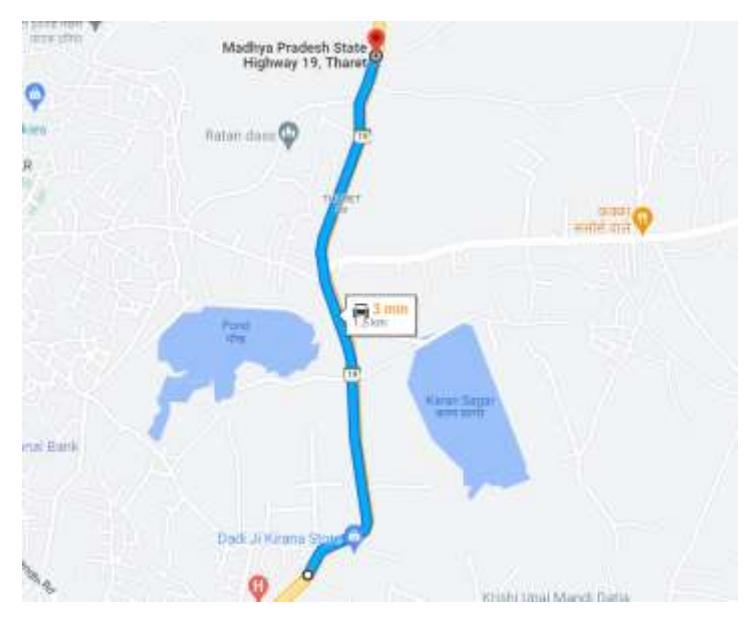
Figure 3: Alignment of the selected Urban Corridor in Dhar

The selected stretch is of 1.5 Km length starting at Krishi Upaj Mandi, Datia and ending at Ritika Marriage Hall on SH-19 in the district of Dhar. The road starts near Krishi Upaj Mandi, the farmers market located in Datia town and ends at the nearest median diversion to Ritika Marriage Hall. The predominant land use along the stretch is commercial with some share of residential, with presence of big and small shops, car repairing stores, fruits and vegetable vendors. The traffic on this road is completely motorized, with a large chunk of traffic comprising of people coming to market.

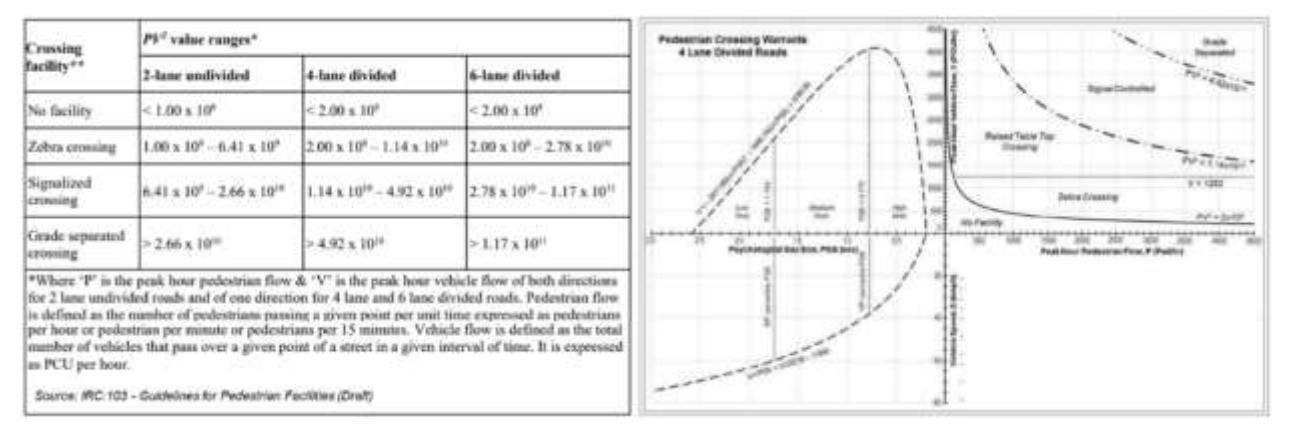
The nomograph for planning pedestrian crossings is presented below from IRC:103 - Guidelines for Pedestrian Facilities (Draft). These can be used to decide a type of crossing facility which shall be provided at a location.

The above warrant charts and PV2 value ranges can be used to identify the need of a pedestrian crossing facility as well as the most appropriate crossing facility for the corridor based on the peak hour pedestrian volume and vehicular volume. From pedestrian count survey, PV² analysis has been carried out at four locations and presented below.

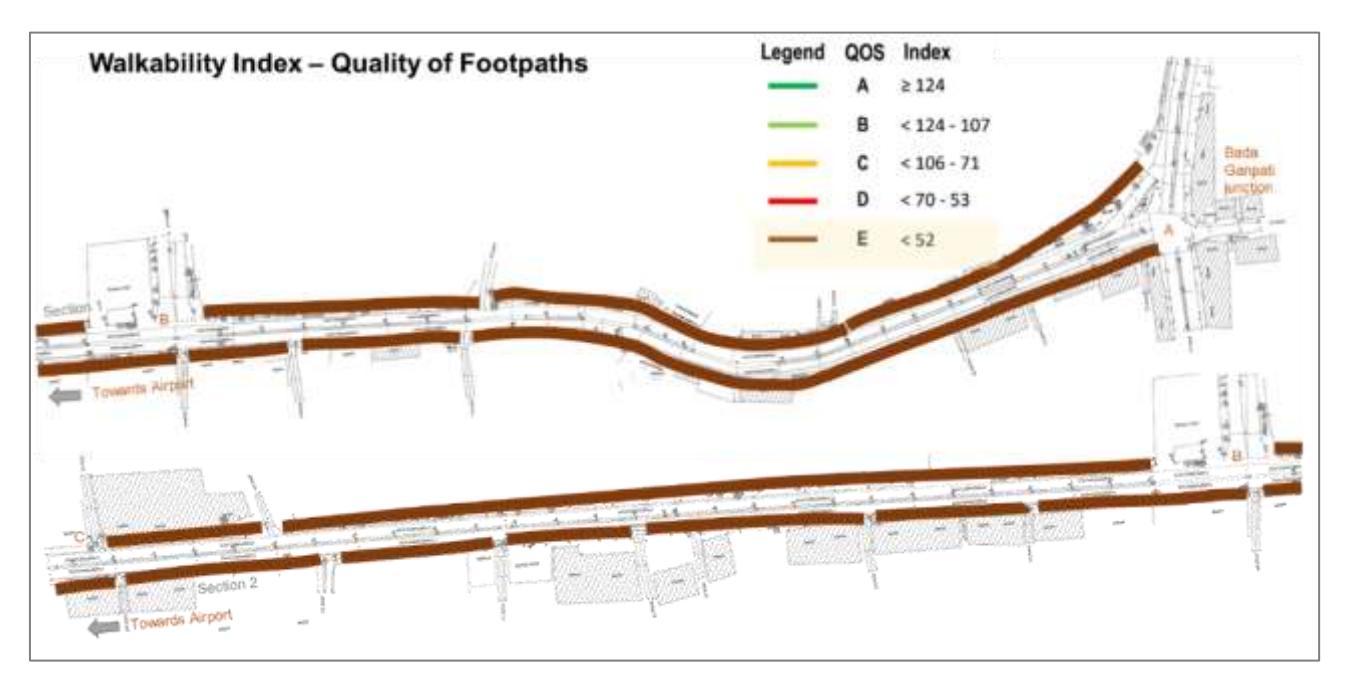
Figure 4: Walkability Index - Bada Ganpati Model corridor

** source: Indian Highway Capacity Manual (Indo-HCM) 2012-2017 - Quality of Service for Footpaths (Table 9.14)

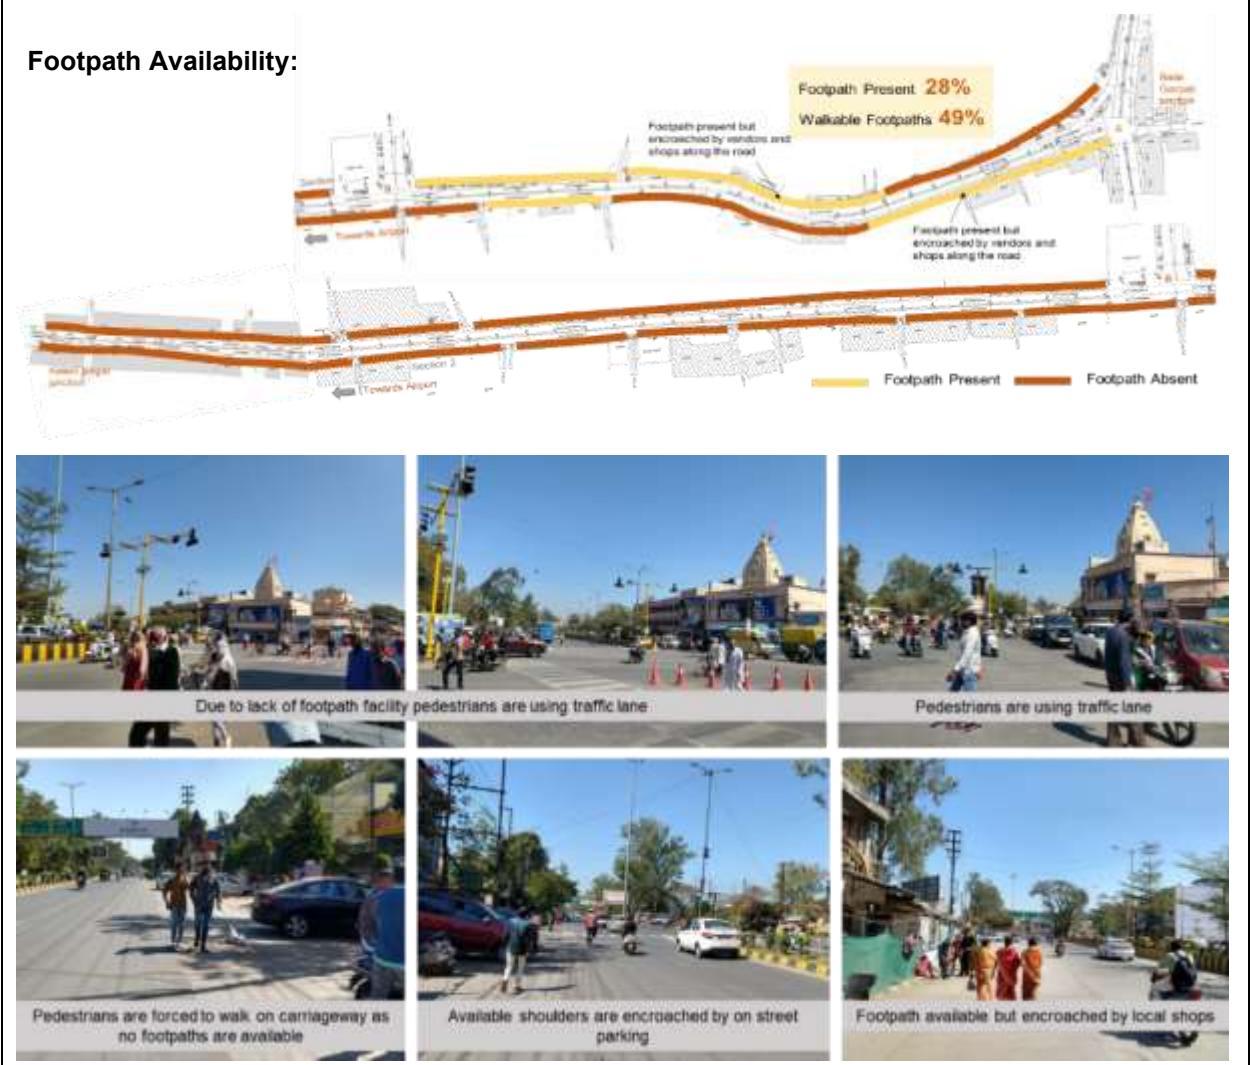
- Due to lack of facilities to walk along the roadside, it is seen that pedestrians are fully or partially using the traffic lane to walk along the road. This increases the pedestrian's exposure with the motorized traffic.
- Also, footpaths are not continuous, and they are encroached mostly by vendors even, if available which is making it non usable by the pedestrians.
- Only 28% of the stretches have footpath facility for pedestrians. But only 49% of available footpaths are in walkable condition, remaining parts are mostly encroached by local shops, vendors and on street parking.

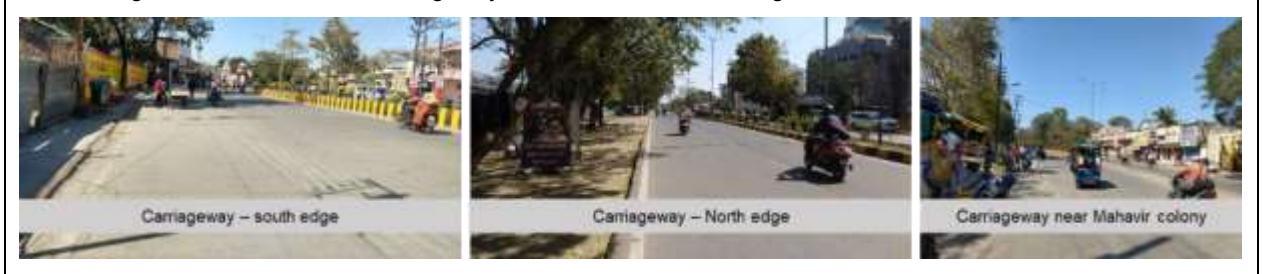
- The divided carriageway on both sides of the corridor has approximately 3 lanes of width, of which the inner twolane width is used by motorists while the outer lane is used as shoulder, for a variety of purposes including pedestrians (in the absence or presence of unused footpaths), encroachment by vendors and parking.
- Inner two-lane width is constant but outer lane is not constant throughout the corridor, boundary is not clearly defined through curbs. Carriageway near Mahavir colony is not maintaining constant width.
- Throughout the corridor, the carriageways have faded road markings and, in some stretches, absent.

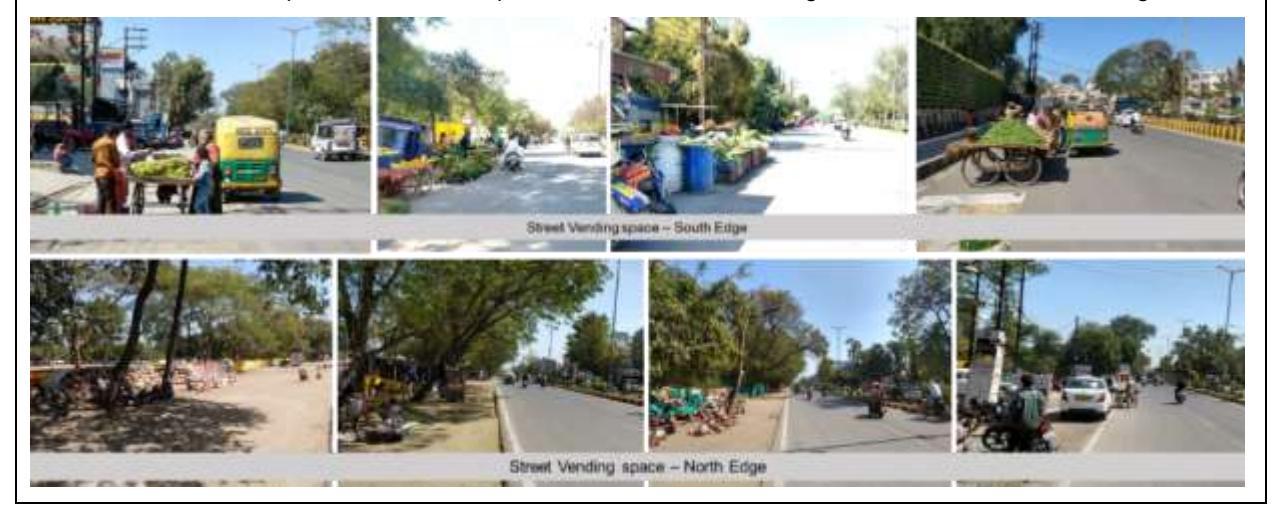
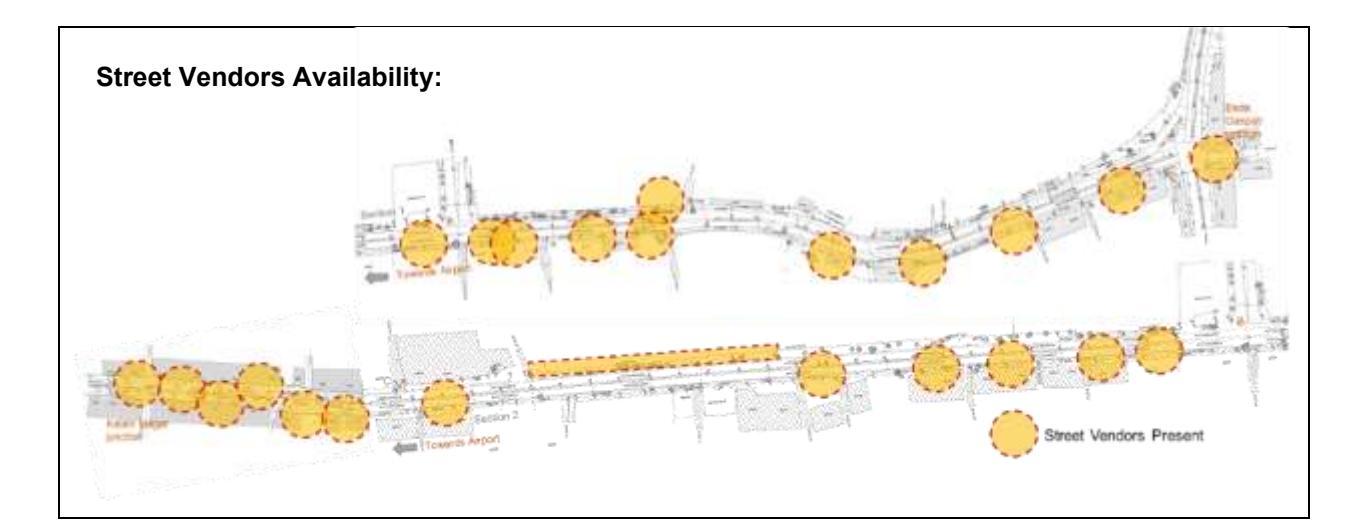
- Street vendors are present throughout the stretch as depicting in the below map. All street vendors occupy space on the roadside shoulder and carriageway.
- Unauthorized occasional street vendors like food seller, vegetable sellers are seen on the south edge of the corridor near Janta colony, Sitaram Park colony, Mahavir colony, Ganga colony, Kalani Nagar.
- On the north edge of the corridor, a wide earthen shoulder is available from the Bada Ganpati Square till the RAPTC Playground. This space has roadside trees, occasional street vendors and parked vehicles.
- Street vendors i.e., potters, bike seat repair are seen on the north edge of the corridor near RAPTC ground.

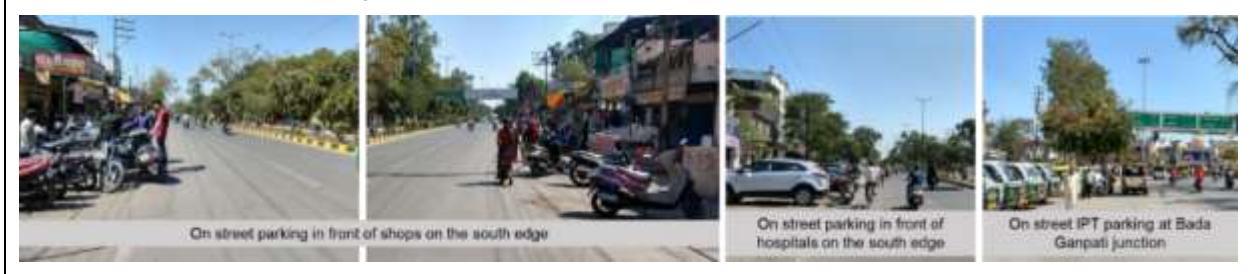
- On-street car parking was observed throughout the stretch as depicted in the below map.
- Presence of shops, malls, and hospitals on the south edge of the corridor lead to high number of private cars parked on the road.
- IPT parking is observed near Bada Ganpati junctions on the north edge.
- There are no proper allocated pickup/stop points for the IPTs along the stretch.
- Sudden stop of the vehicles (IPTs) on to the highspeed traffic could cause rear-end collisions. This is also increasing the pedestrian presence near these points and hence can influence pedestrian related crashes.
- Presence of informal parking on the wide-open roadside is a potential roadside hazard.

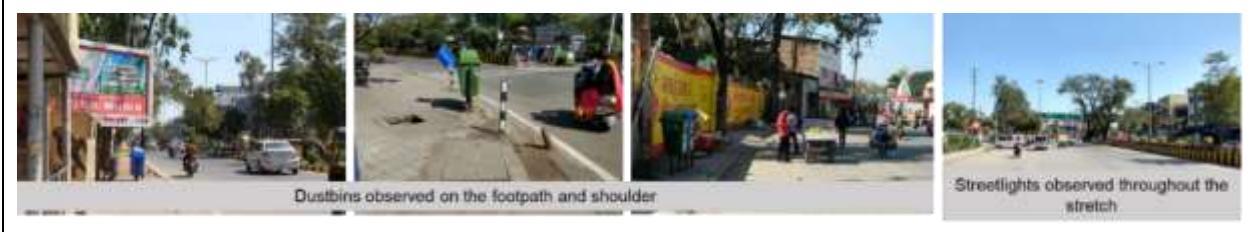
- Dustbins were present at some locations but are not in use by the road users.
- Street lights were present in the median of the corridor.
- Bollards, railings were not observed throughout the stretch for pedsetrain safety.
- Toilets were not observed on the road.

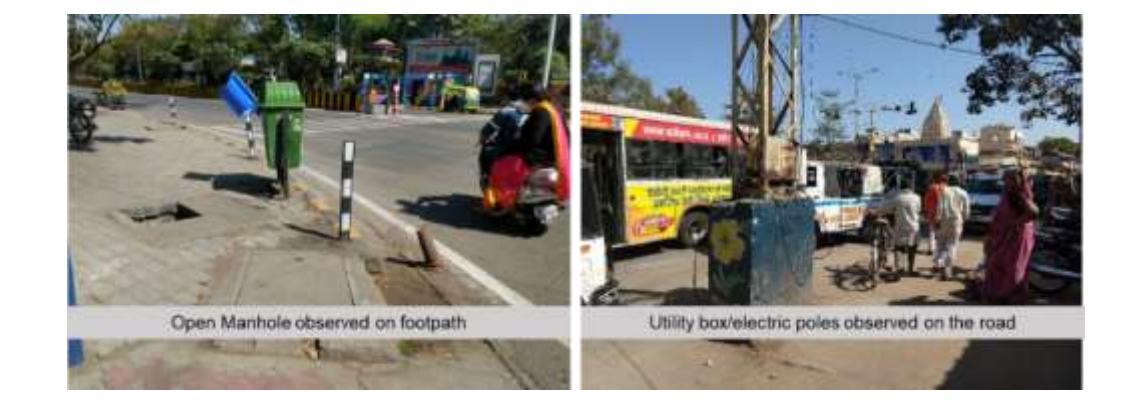
- It can cause water to stagnate on roadside and sometime extend to the one of the lanes. This could cause aquaplaning related crashes due to loss of control of vehicles.
- Presence of unprotected electric poles/boxes, manholes were noticed which pose as roadside hazard.

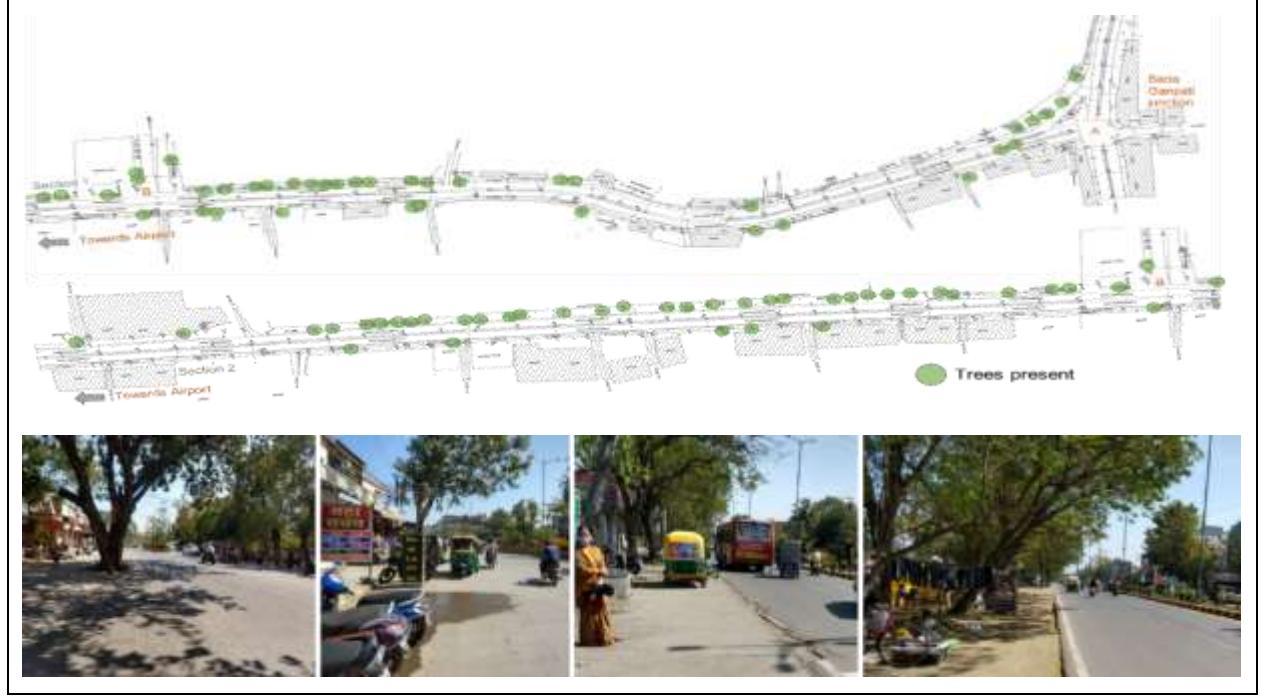
• Many trees were observed throughout stretch mainly on the north edge of the corridor as depicting in the below map.

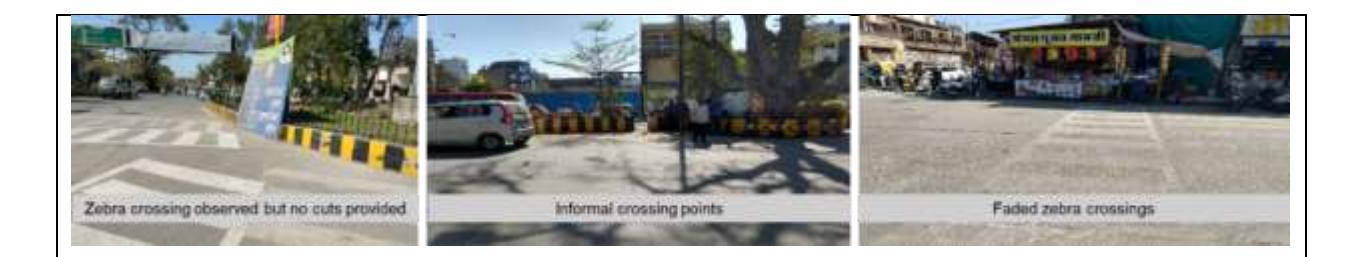
- Presence of inadequate facility for pedestrian crossing (such as faded zebra cross markings, absence of refuge island etc.)
- Informal crossing points are created at some locations which is used by pedestrians.
- Midblock pedestrian crossings were not observed along the corridor and this gives rise to jaywalking and pedestrian related hazards

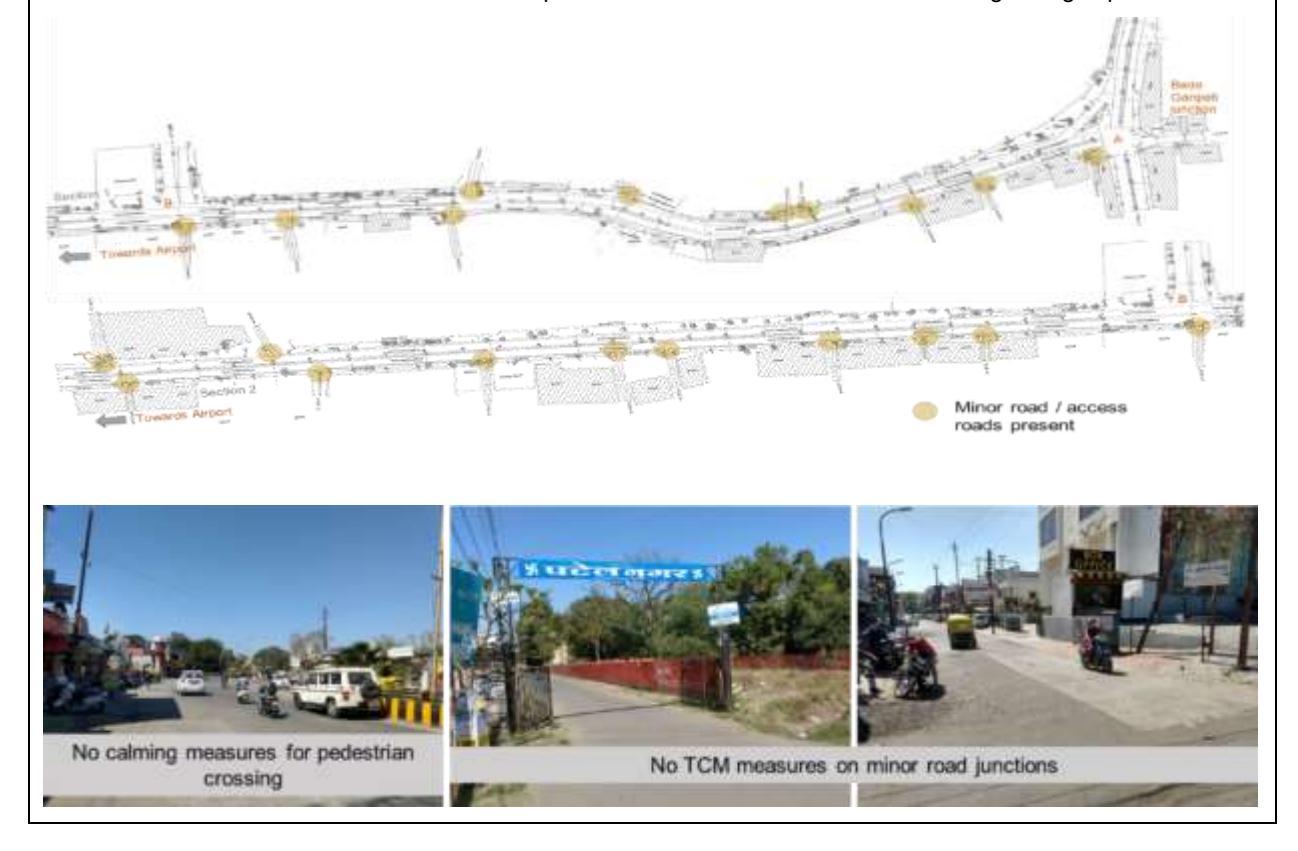
- Multiple access openings are present along the road without any traffic calming measures, creating multiple conflict points between the vehicles accessing the opening and high-speed traffic. This could result in front-side, rear-end and head-on type of collisions.
- The land use on south edge of the road is predominantly commercial leading to high volume of pedestrians. There are chances of conflict between the pedestrians and motorized vehicles moving on high speed.

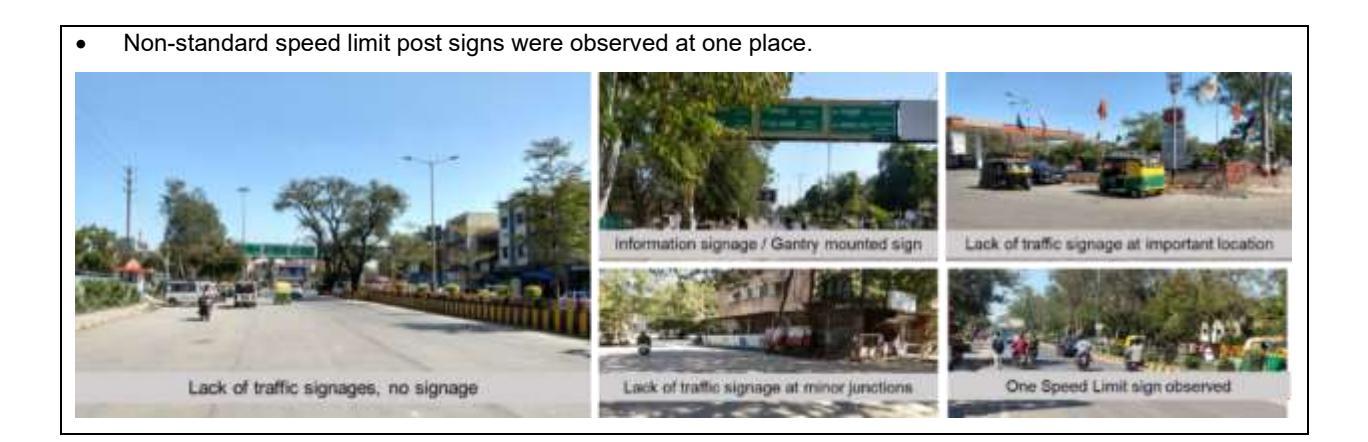
- Lack of traffic signages throughout the stretch. No signages are seen on the stretch. Only Information signages/advance direction signs were there.
- Various minor junctions leading to nearby residential areas are available without any proper signages and safety measures for the road users.
- Access to the petrol pump is provided without any proper signage or physical separation from the carriageway, which is acting as a conflict point for the access and through traffic.
- Gantry mounted advance direction signs were observed at Bada Ganpati junction and between Shanidham Chouraha and Geetanjali hospital junction mid-block.

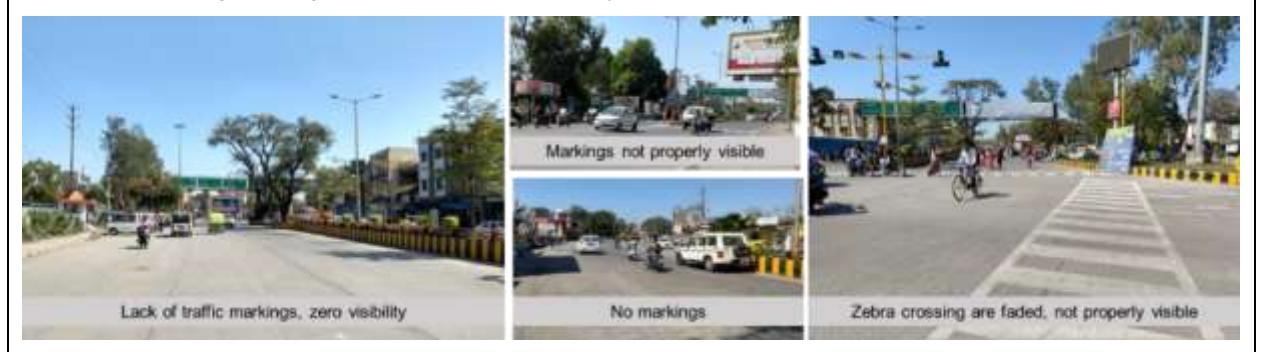
- Road markings like centerline and edge line markings are not continuous throughout the stretch and are missing at majority of the sections.
- Road markings are completely missing at some stretches.
- Zebra crossing markings are present but are mostly faded.

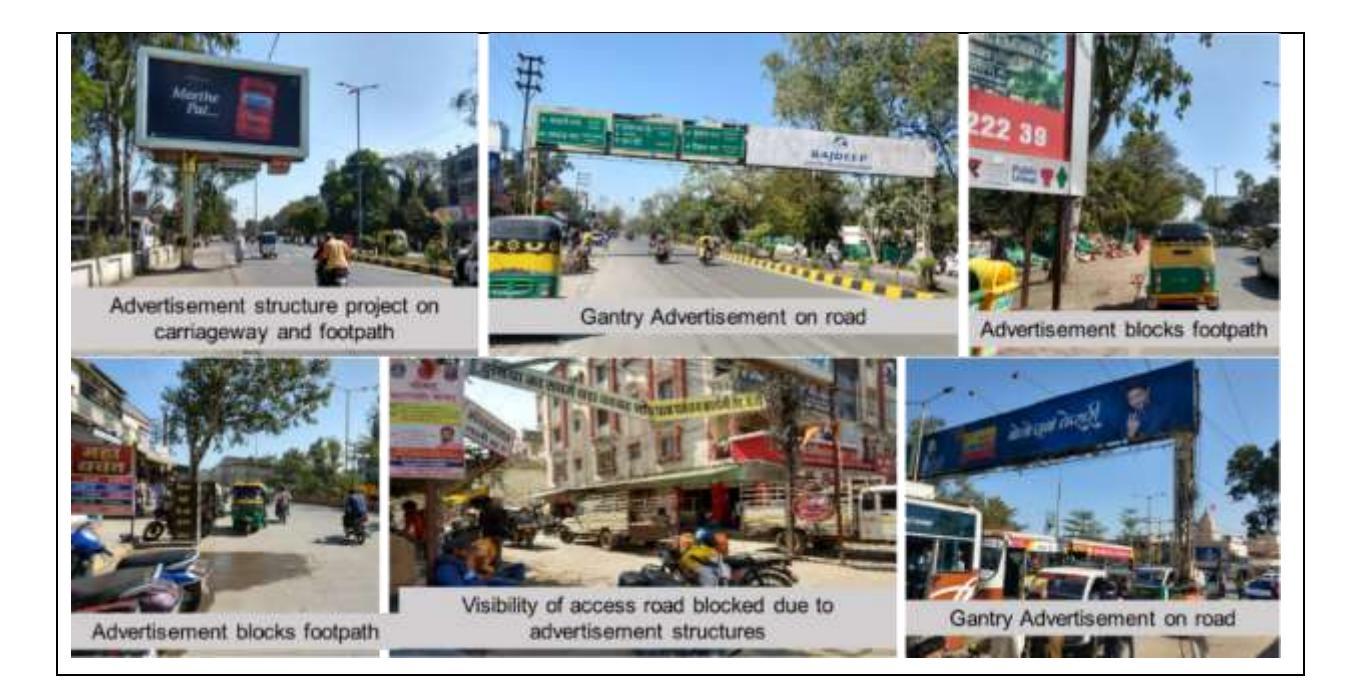
- Advertisement structures are projected on carriageway and footpath/shoulder area.
- The visibility of the access road is very poor due to the presence of structures on the corner of the access point at Shanidham Chouraha.
- Shops advertisement or display are placed mainly on footpath blocking the walking area.
- An unipole advertisement structure (opposite to Narsingha Vatika) placed in such a way that it is projected on the carriageway.

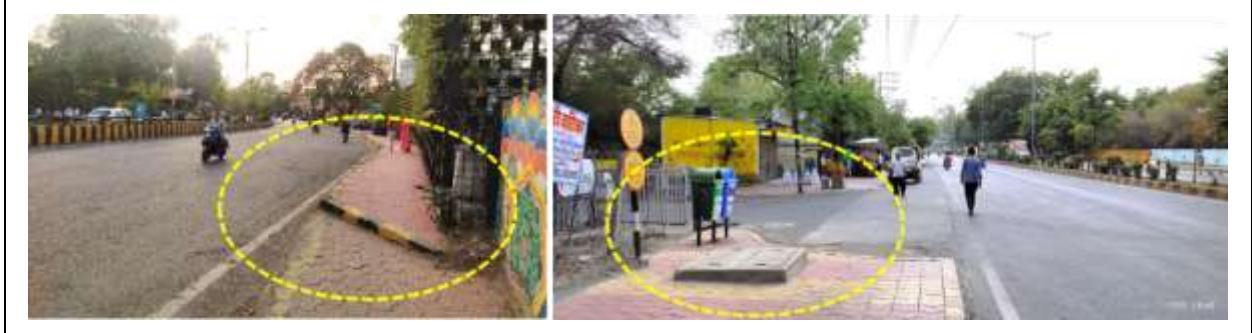
• No disabled friendly accessibility facilities were observed throughout the corridor.

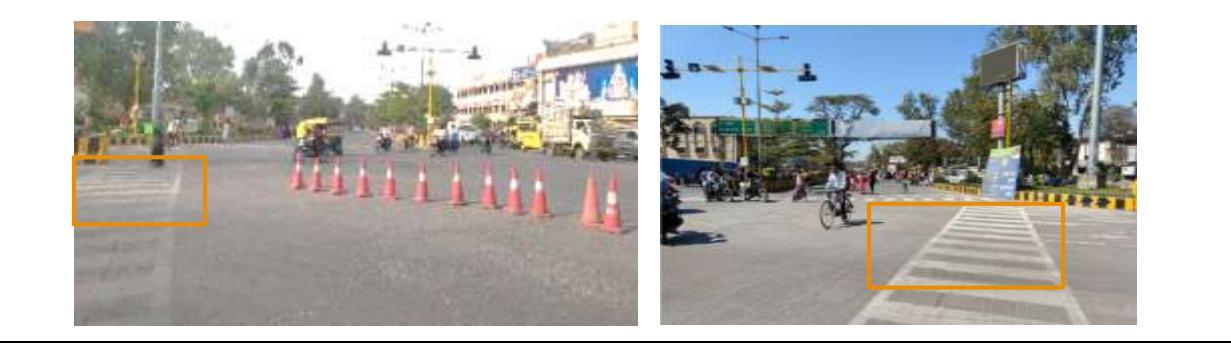
• Pedestrian facilities are not properly designed. At Bada Ganpati junction, pedestrian crossings are ending at traffic island which doesn't have any provision for pedestrians.

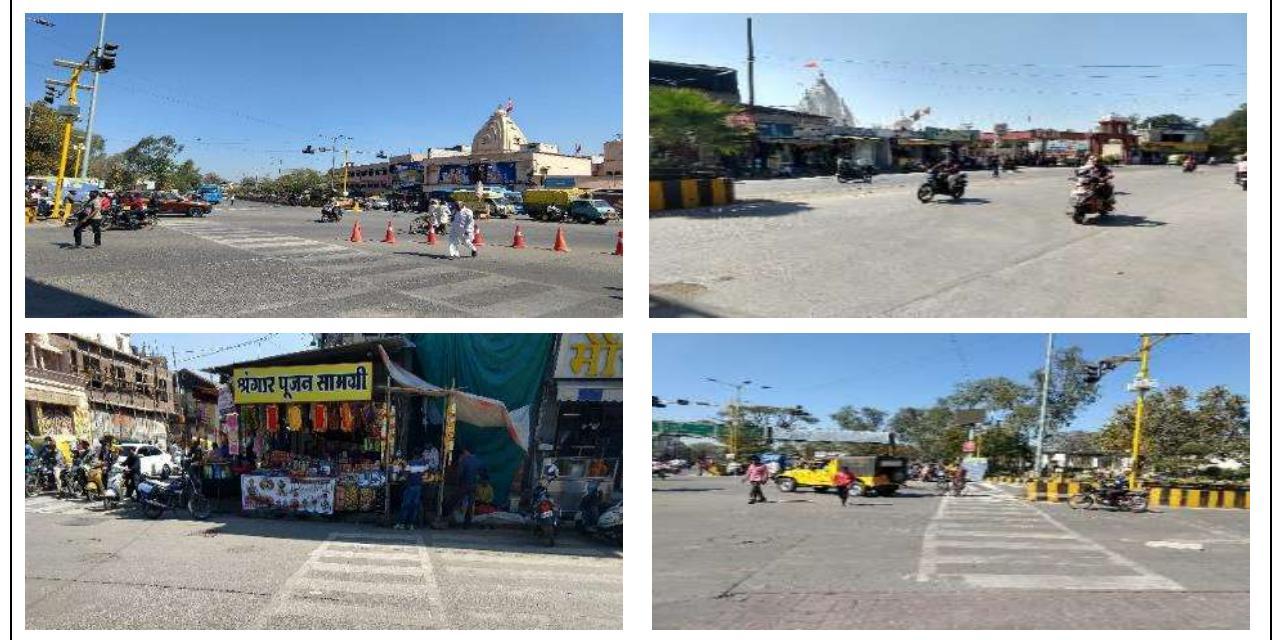
Bada Ganpati Square Junction

- Temporary left-turn channelization is present on road from Gangwal circle at Bada Ganpati junction using traffic cones.
- Presence of an uncontrolled intersection creating several conflict points, causing potential speeding related crashes as the road users are not guided at the intersection.
- Encroachment by vendors is visible at the corner of the junction.
- Presence of inadequate facility for pedestrian crossing at the junction with faded markings and absence of refuge island. The north-east corner of the junction (with temple) has some area with paver blocks (presumably for pedestrian refuge. However, this is flush with the pavement and therefore is encroached by motorists).

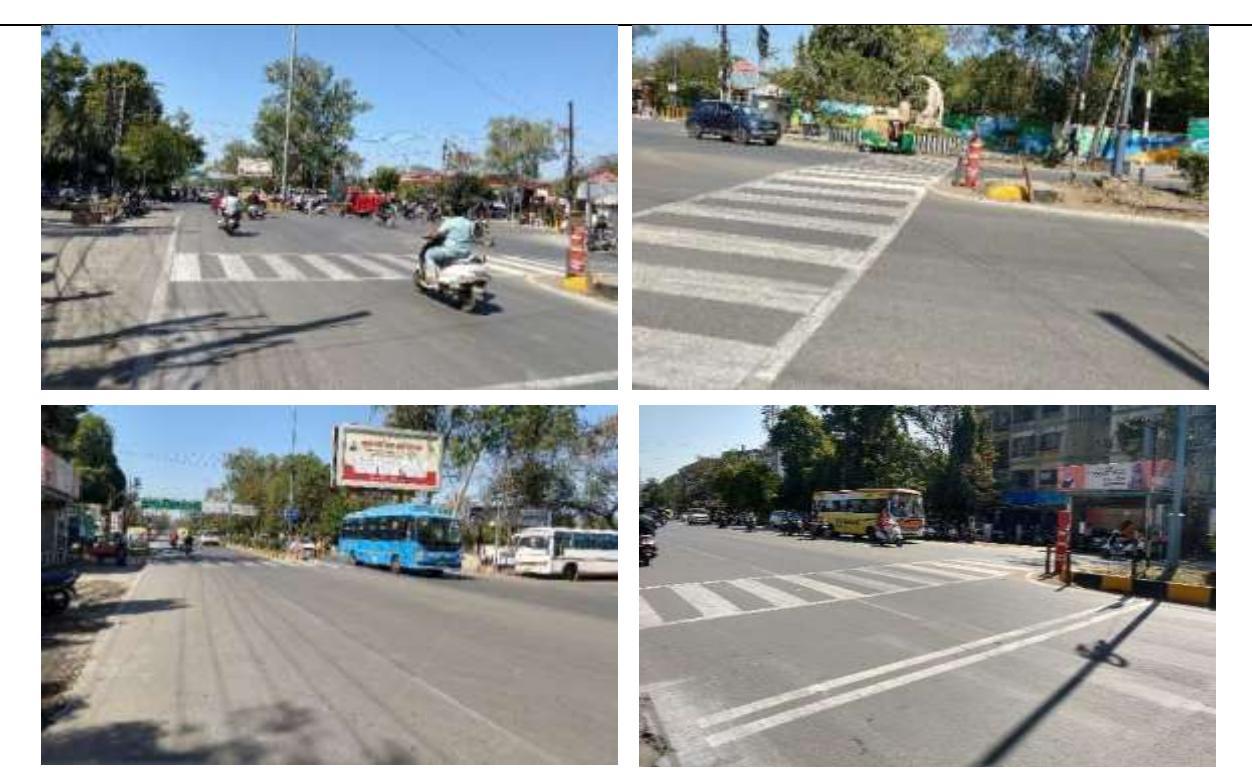
Junction at Geetanjali Hospital

- This is an unsignalized junction
- Median divider on the west leg is terminated before the access to the IOCL petrol pump on the north-west corner and leaves a wide-open median opening. This and the absence of left turn channelizing islands along with large corner radius encourages unchanneled and haphazard movements across the junction
- Bus Stop on the south edge of the west leg is very close to the junction

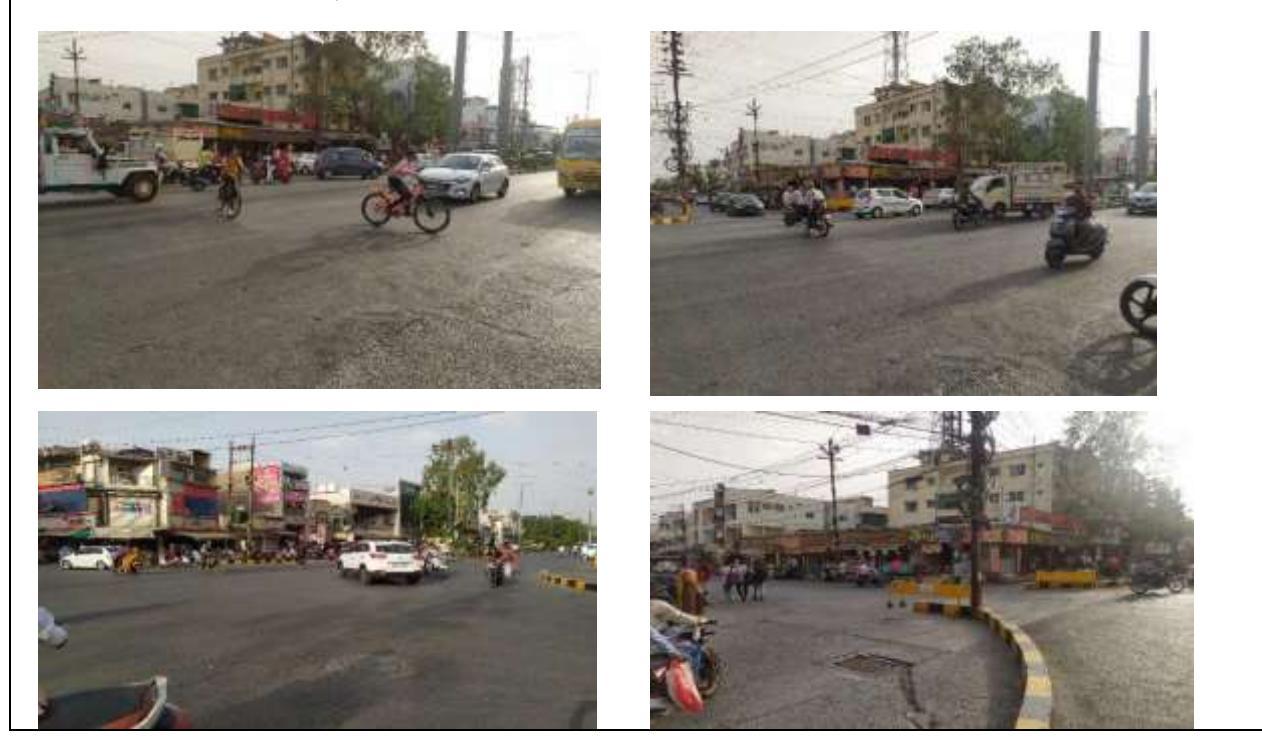
Kalani Nagar Junction

- Permanent left-turn channelization using kerbs is present at all corners of intersection. Only two left turn channels are currently being used for turning, other two are being used for parking.
- Presence of an uncontrolled intersection creating several conflict points, causing potential speeding related crashes as the road users are not guided at the intersection.
- Presence of inadequate facility for pedestrian crossing at the junction.
- Buses and IPTs stop very close to intersection.

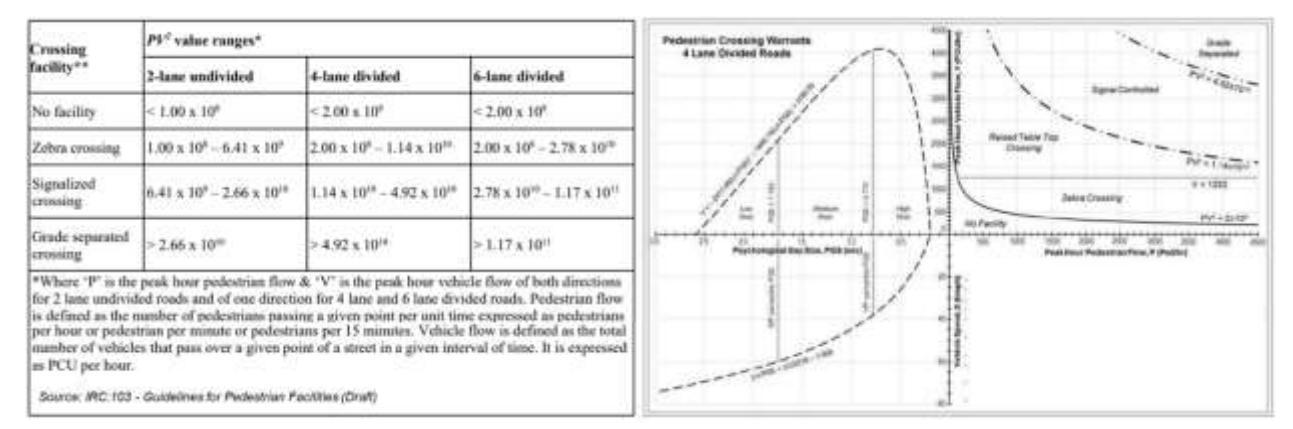
The nomograph for planning pedestrian crossings is presented in the figure below (based on IRC:103 - Guidelines for Pedestrian Facilities (Draft)). These can be used to decide upon the type of crossing facility that shall be provided at a location.

The above warrant charts and PV² value ranges can be used to identify the need of a pedestrian crossing facility as well as the most appropriate crossing facility for the corridor based on the peak hour pedestrian and vehicular volumes. From the pedestrian count survey, PV² analysis has been carried out at one location and presented below.

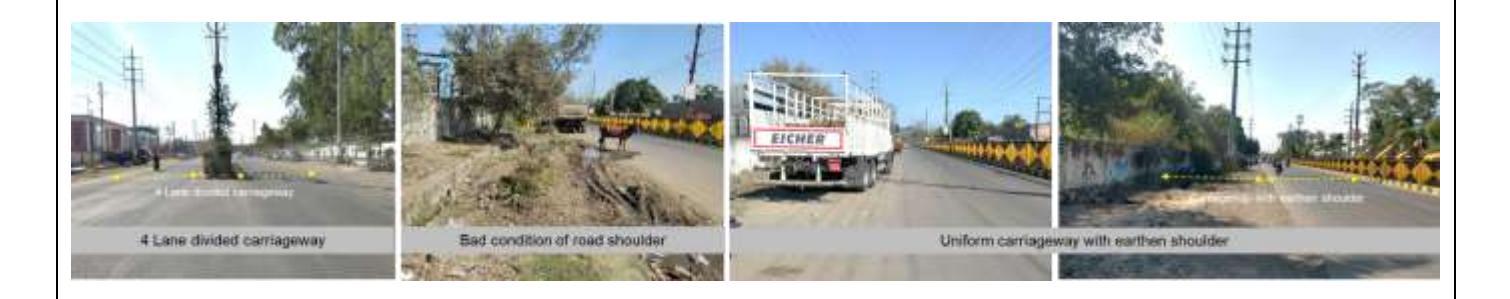
- The divided carriageway on both sides of the corridor has 2 lanes of width with 5 6 m wide earthen shoulders. The carriageway condition is overall good, but shoulders are poorly maintained.
- There is a slight steep slope in carriageway near the Eicher VE parts distribution center factory on 750 m East-West segment of the corridor. Also, carriageway is slightly bend due to presence of Ganesh Mandir placed at the median.
- The shoulders are used by pedestrians (in the absence or presence of unused footpaths) and encroached by onstreet cars, two wheelers, trucks, and vendors.
- Throughout the corridor, the carriageways do not have road markings except edge marking on some stretches.

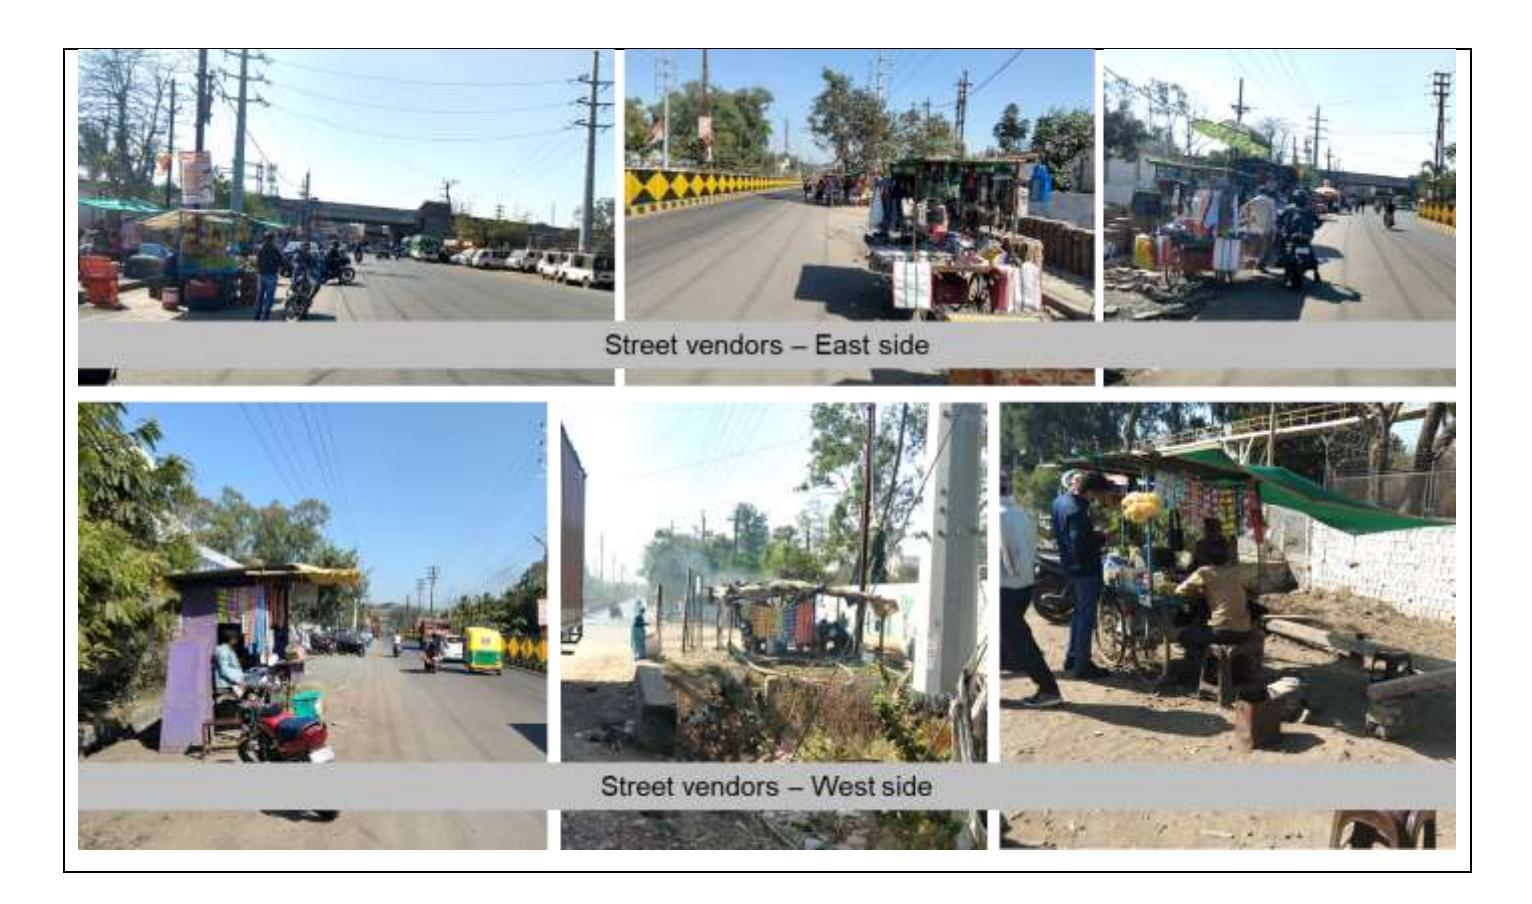
- Street vendors are available throughout the stretch as depicted in the below images. All street vendors mainly occupy roadside shoulder space and footpath.
- Unauthorized occasional street vendors like food sellers, shops, etc. are observed on the eastern side of the corridor in front of the Eicher Chowraha bus stand and on the western side of the corridor near Eicher Factory gates, and banks.
- Vendors are also observed at the Rau-Pithampur Road T Junction and on the East-West segment of the corridor. Vendors like tyre repairing, small garages, etc. are observed near factory.

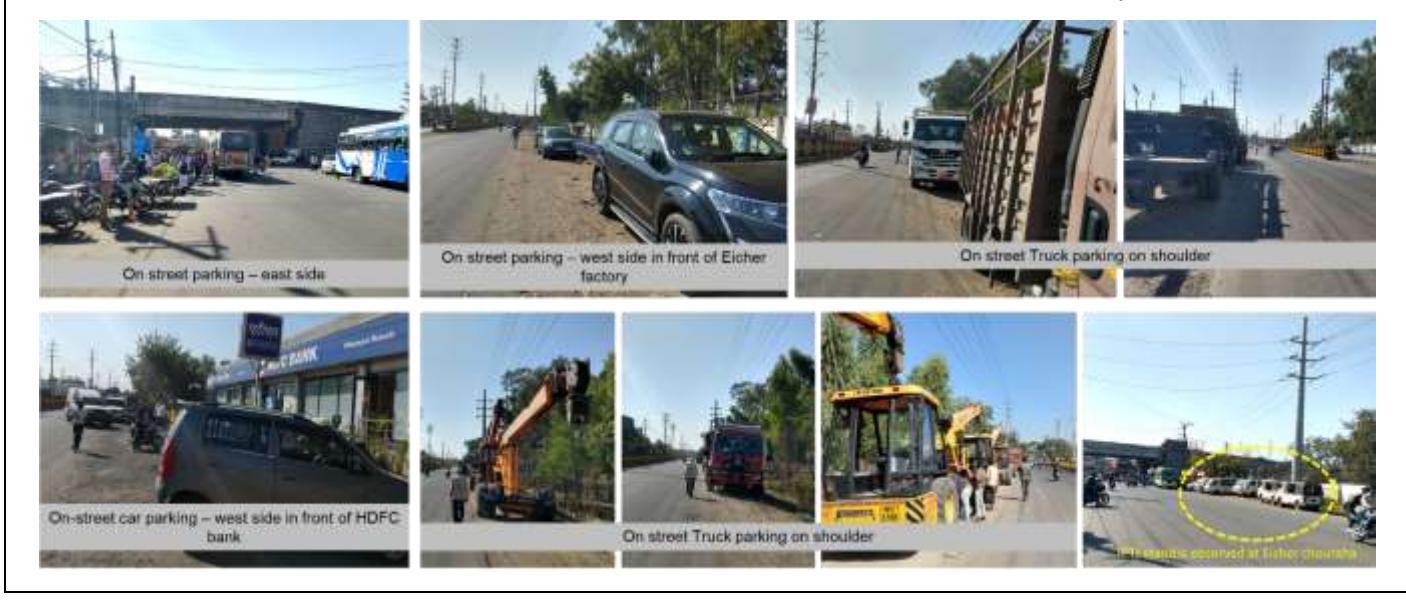
- On-street car and two wheeler parking are observed along the corridor as depicted in the below map.
- Presence of Eicher Factory, HDFC bank, and other factories throughout the corridor are leading to high number of private cars and two wheelers parked on the roadside shoulder of the corridor.
- High number of trucks are parked on shoulder near factory gates for the purpose of loading and unloading of materials.
- IPTs stand is observed near Eicher Chowraha bus stand on the western side. Vehicles are parked on the shoulder.

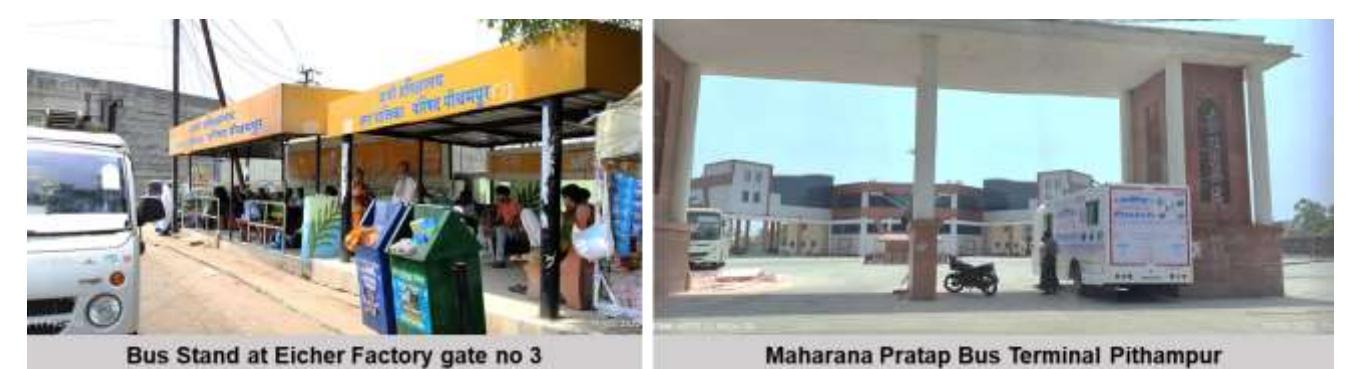
- A formal bus stand and shelter is situated on the western side of the start point of the corridor located at the Eicher junction of the vehicle underpass with NH79. Buses have been observed to stop at both sides of the point.
- Maharana Pratap Bus Terminal Pithampur is under construction on the eastern side of the corridor opposite Eicher Factory.
