Urban Model Corridors (Pilot districts -Indore, Dhar & Datia)

Draft Environment and Social Management Plan

Madhya Pradesh Rural Road Development Authority

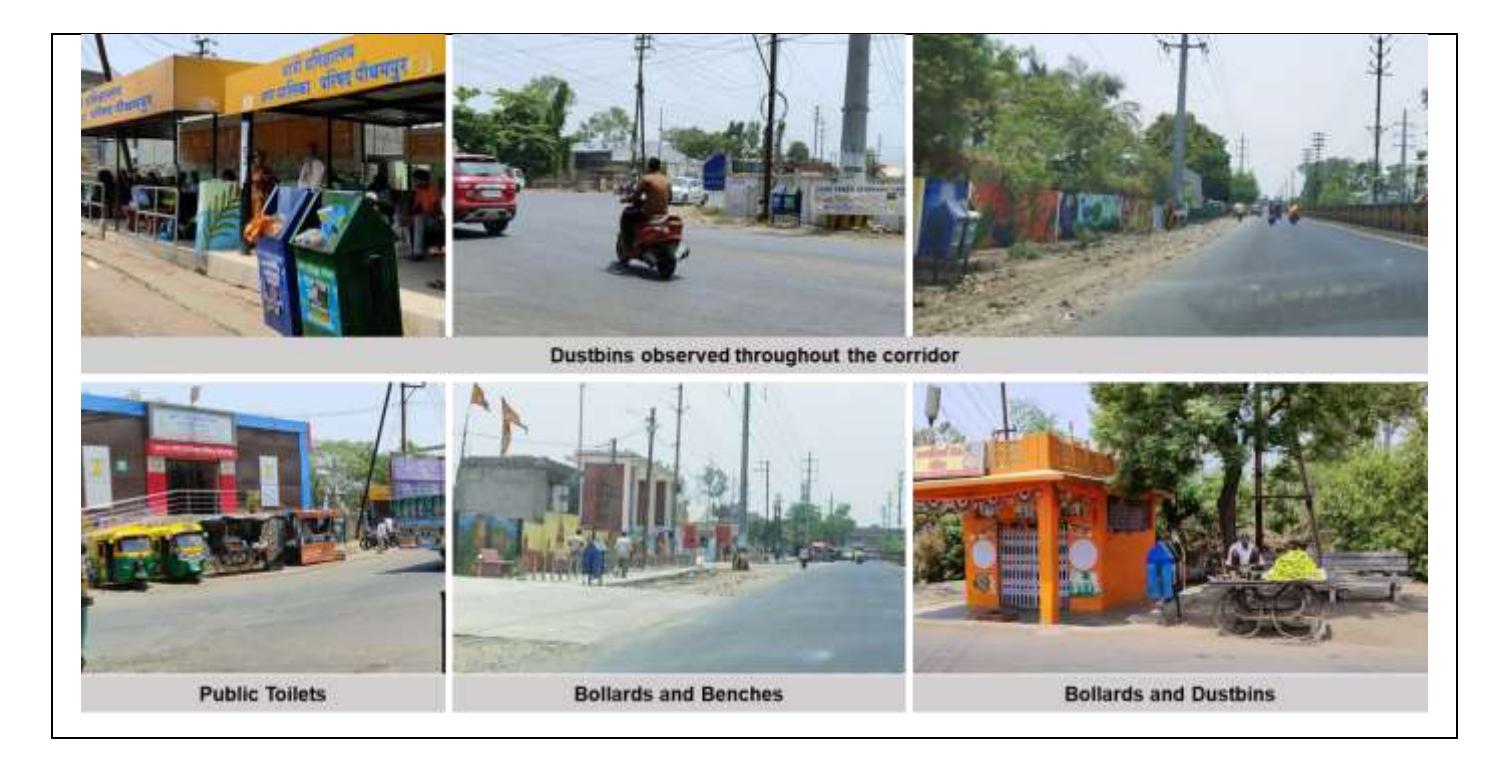
- Dustbins are present at some locations but are not in use by the road users.
- LED street lights are present in the median of the corridor.
- Bollards and railings are not observed throughout the corridor. This increases the risk on pedestrian safety.
- Sulabh complex (toilet) is observed on the western side of the start point of the corridor located at the junction of the vehicle underpass with NH79.
- Street furniture like benches is present along the concrete footpath on the eastern edge of the corridor near new bus terminal.

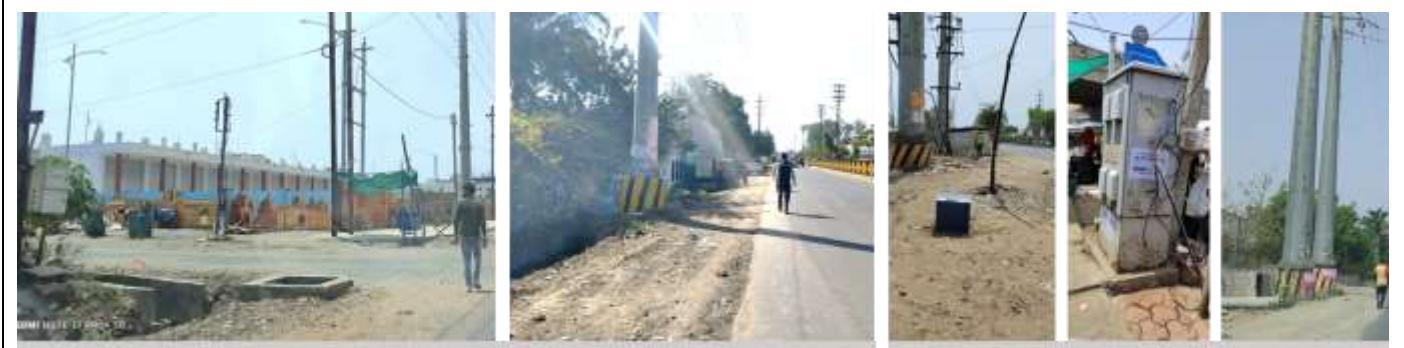
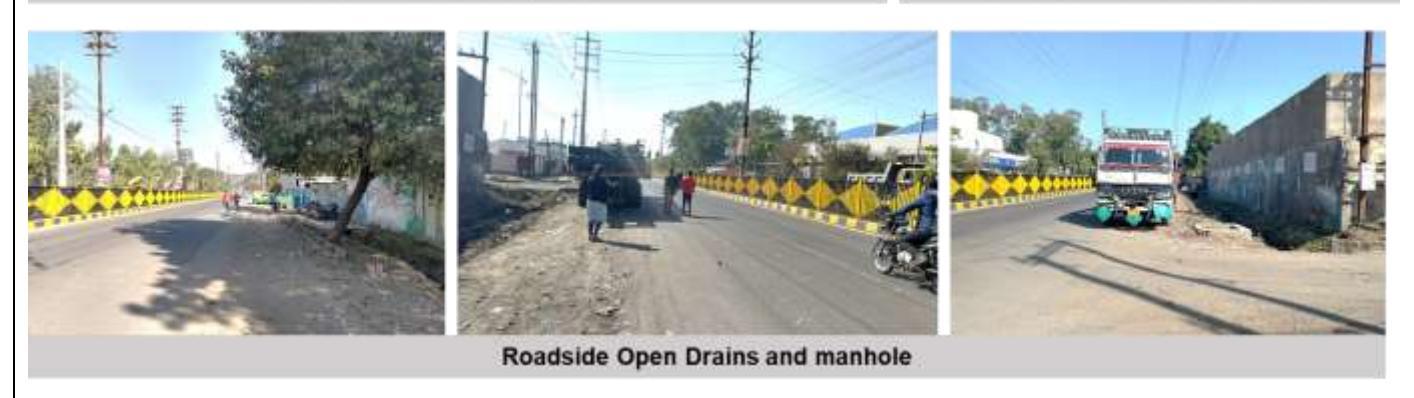
- At some places, presence of open drain has been noticed. This can cause water to stagnate on roadside and sometime extend to the one of the lanes and could result in aquaplaning related crashes due to loss of control of vehicles.
- Presence of unprotected electric boxes and open manholes are noticed, and these poses as roadside hazard.

Open Drains and manhole

Electric boxes, poles on shoulder

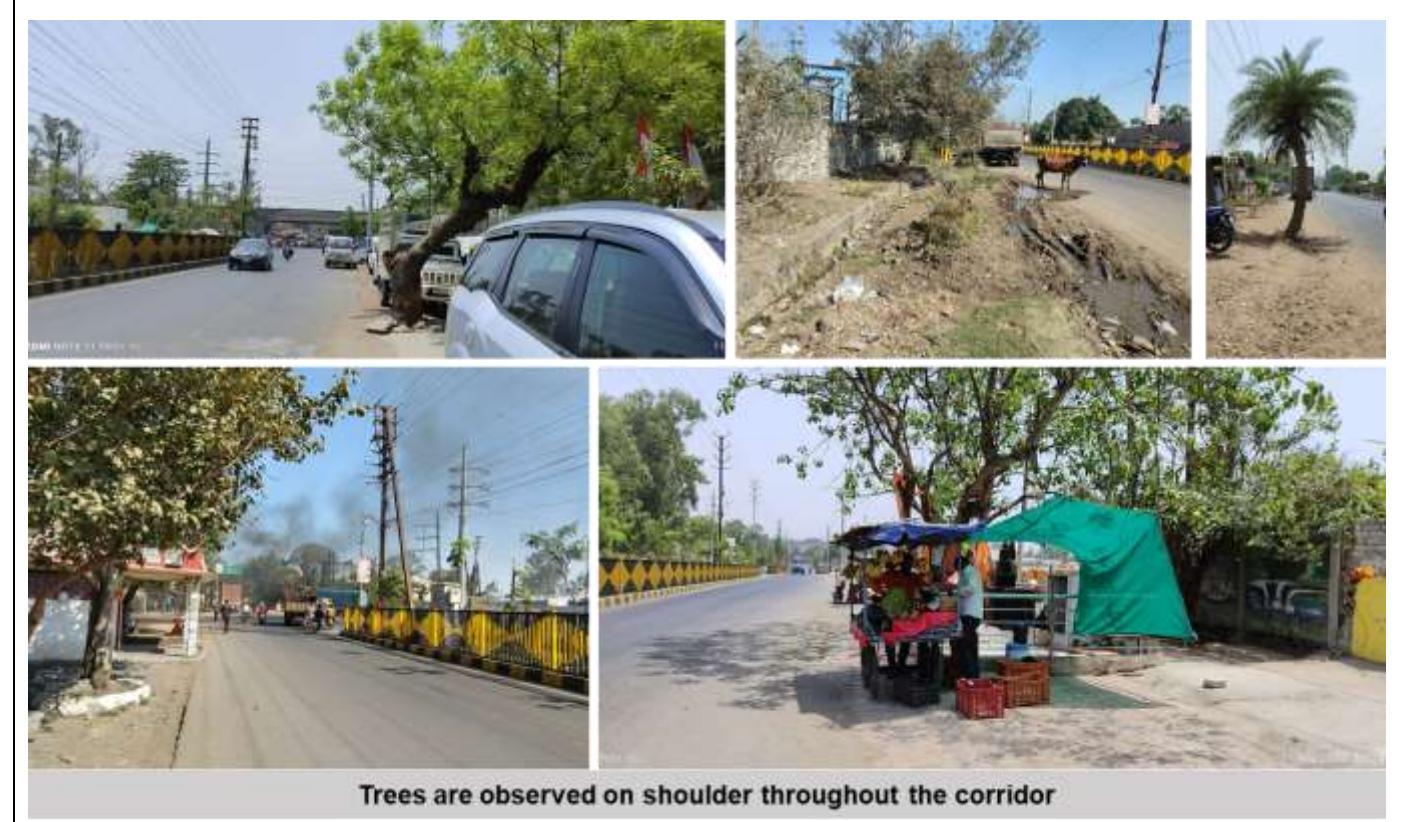
- Trees planted on shoulders create threat to safe movement of pedestrians.
- Many trees are observed throughout the corridor and mainly on the western and northern edge of the corridor.

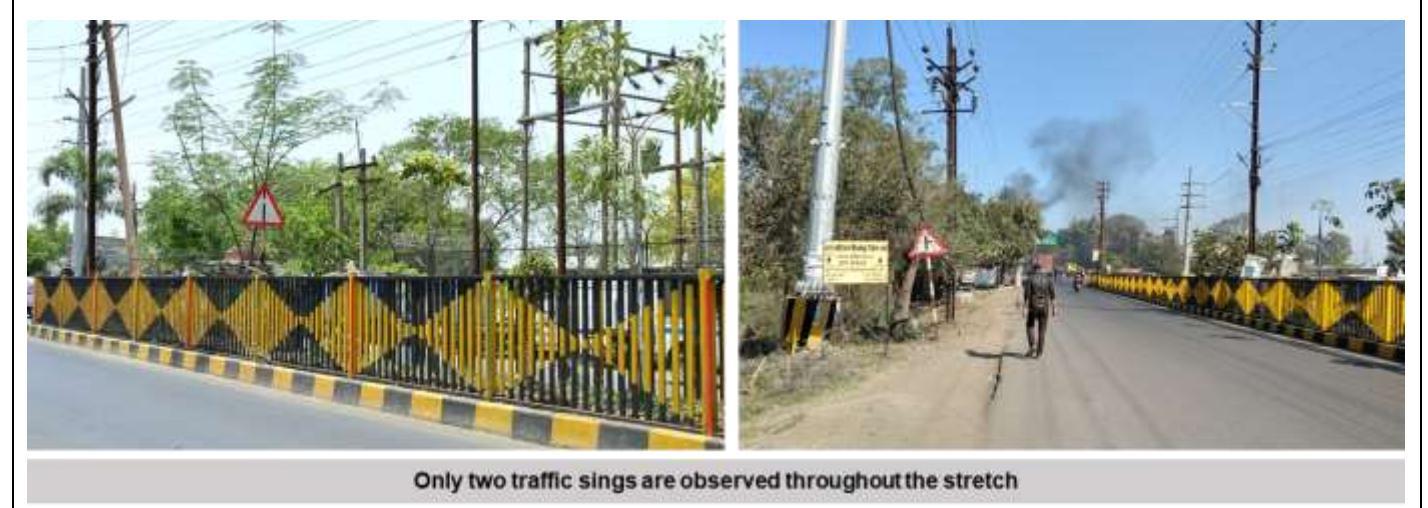
- Lack of traffic signages are observed throughout the stretch. No signages are seen on the stretch.
- Non-standard T junction sign is observed at one place before the Rau-Pithampur Road T Junction. Also, one "Median Gap" sign is observed at end of the median near Eicher Chouraha gate no 3. No other signages are present throughout the stretch.

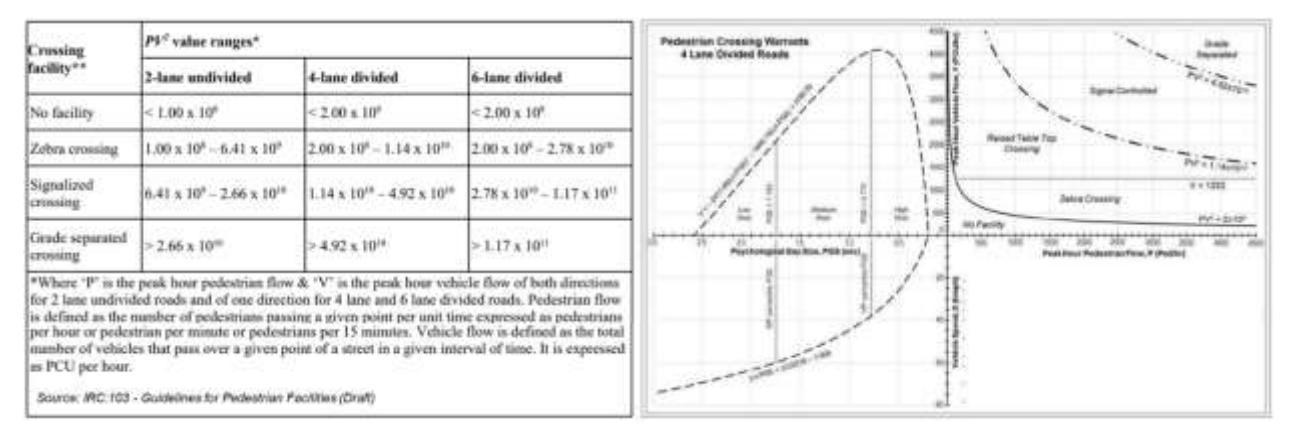
The nomograph for planning pedestrian crossings is presented in the figure below (based on IRC:103 - Guidelines for Pedestrian Facilities (Draft)). These can be used to decide upon the type of crossing facility that shall be provided at a location.

The above warrant charts and PV² value ranges can be used to identify the need of a pedestrian crossing facility as well as the most appropriate crossing facility for the corridor based on the peak hour pedestrian and vehicular volumes. From the pedestrian count survey, PV² analysis has been carried out at one location and presented below.

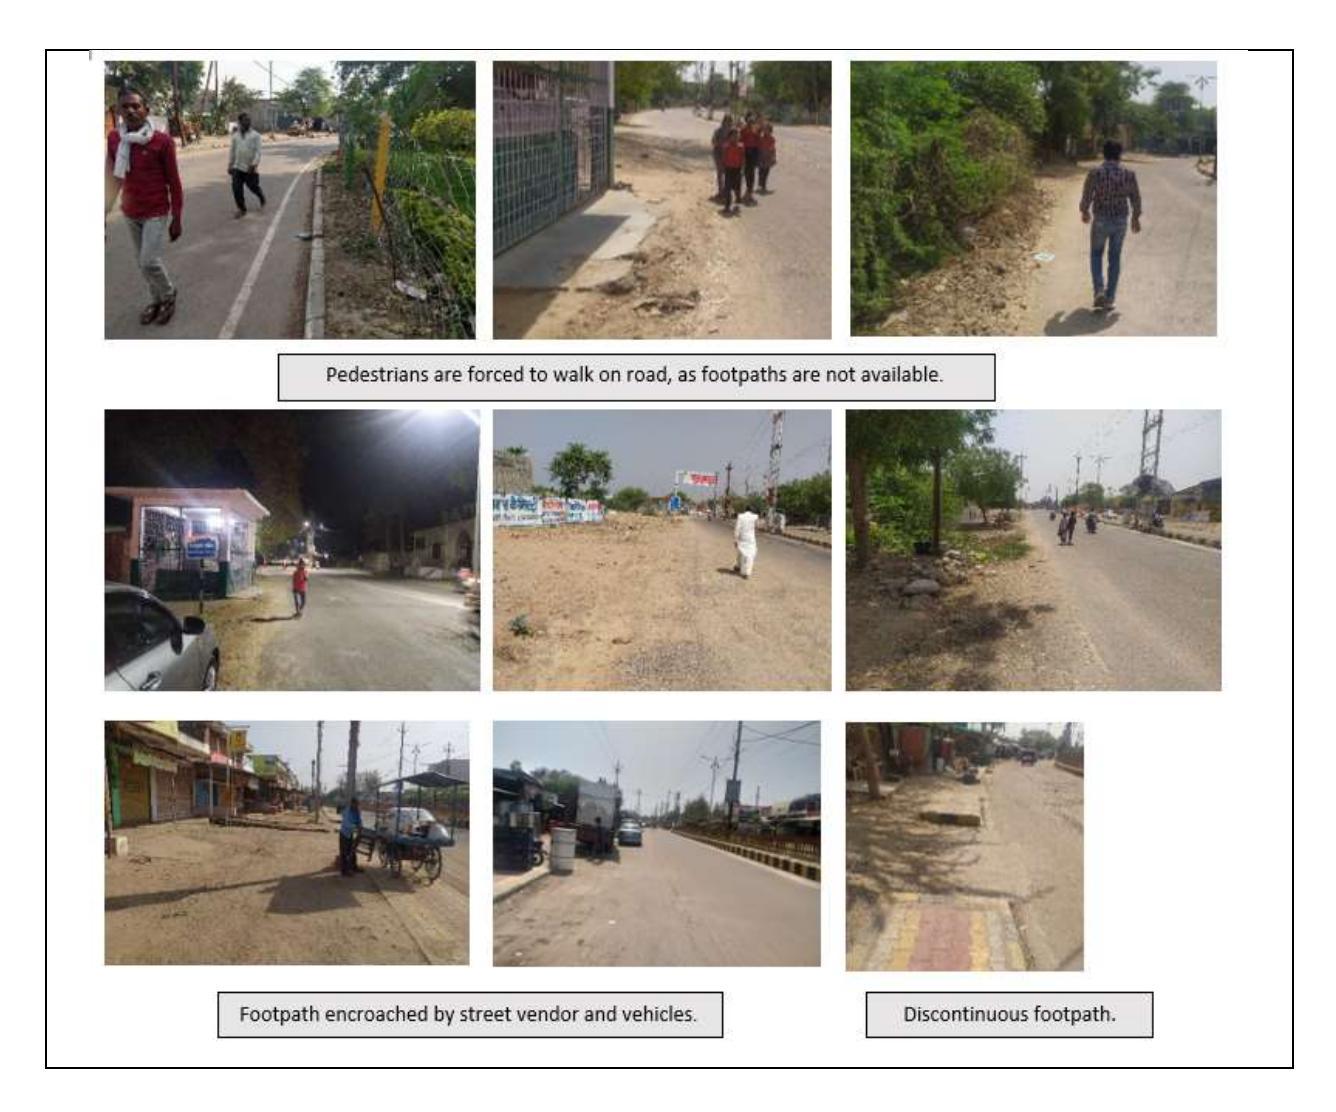
Footpath				
ald Observations:				
Due to lack of facilities to walk along the roadside, it is seen the pedestrians are fully or partially using the traffic lane to walk along the road. This increases the pedestrian's exposure with the motorized traffic.				
 Along the stretch, footpath is available for only 300-meter length of study stretch (20% of stretch) at the southern end, which is also encroached by street vendors, roadside shops for parking motorcycles, placing boards. Footpaths are not continuous. 				
ootpath Availability:				
Towards North				
APMC Mariant Towards South

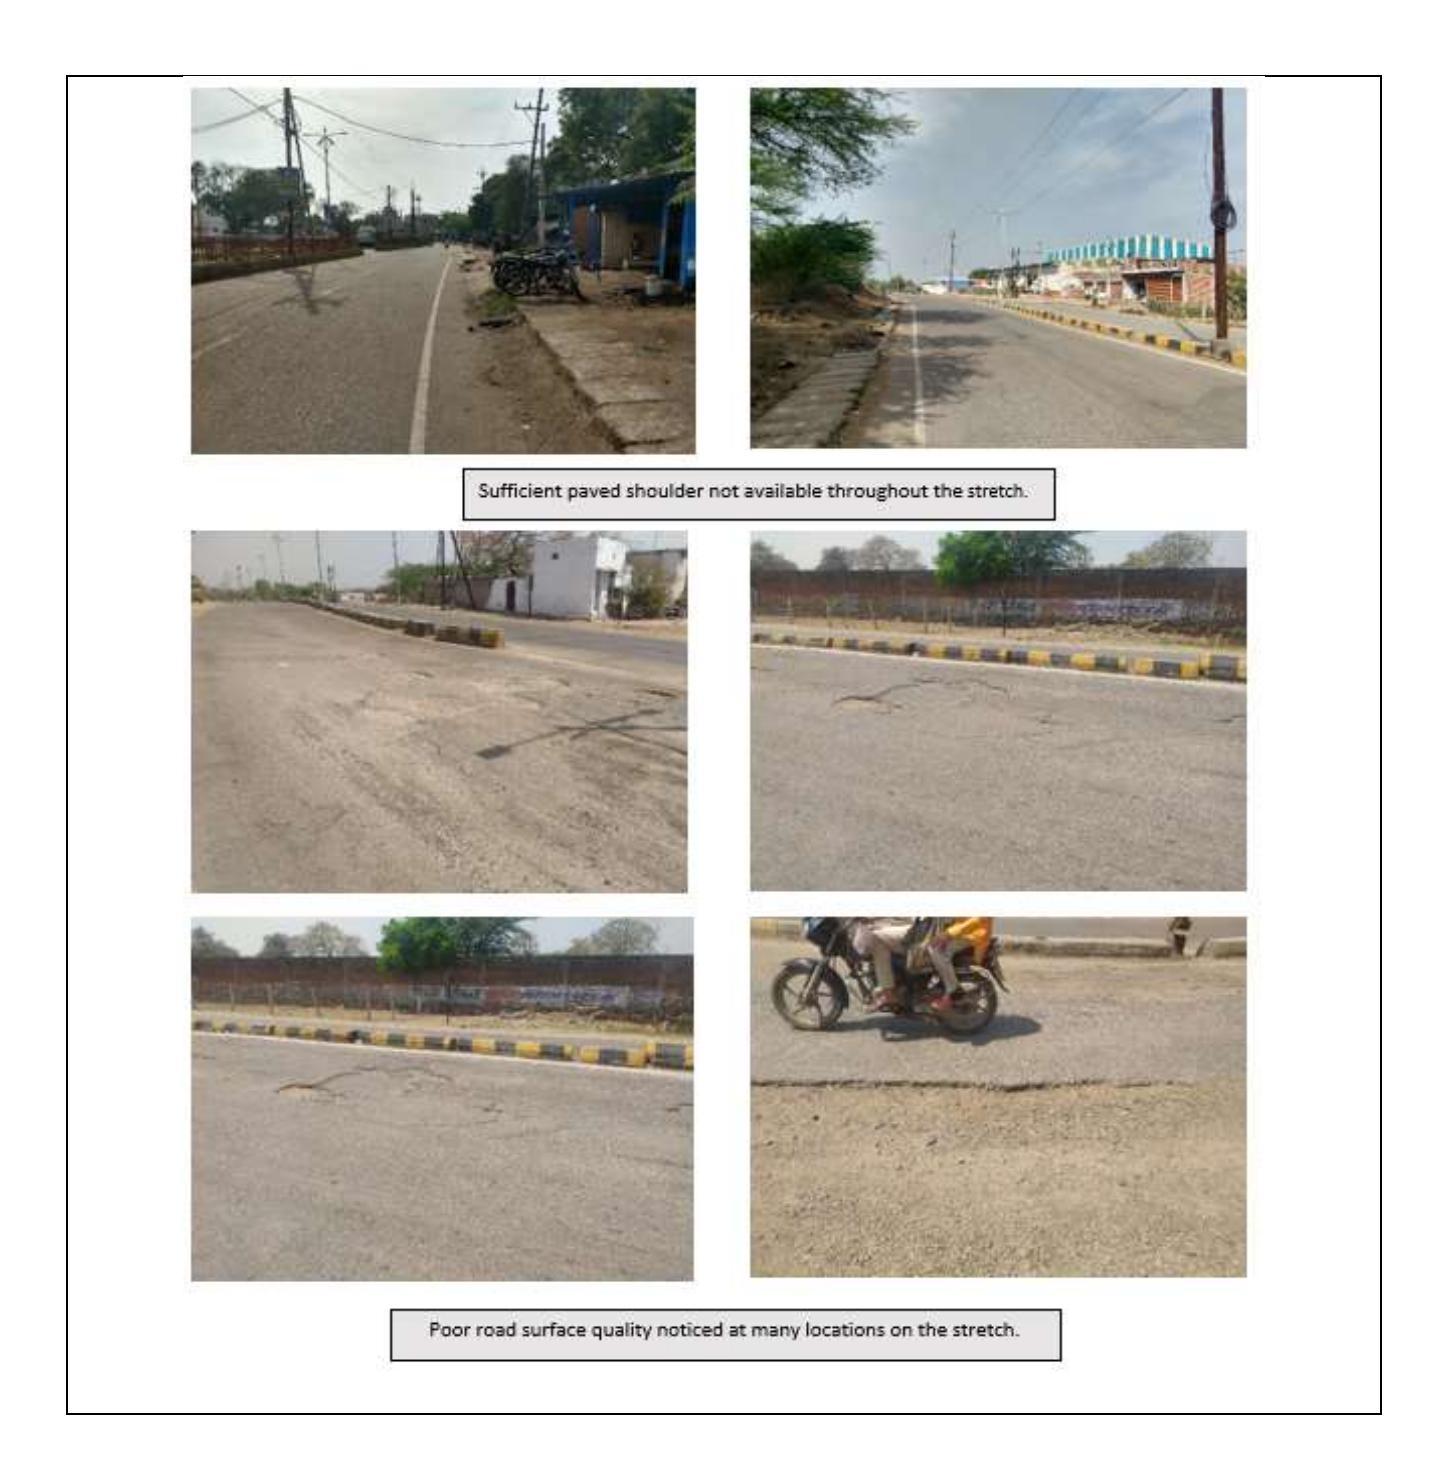
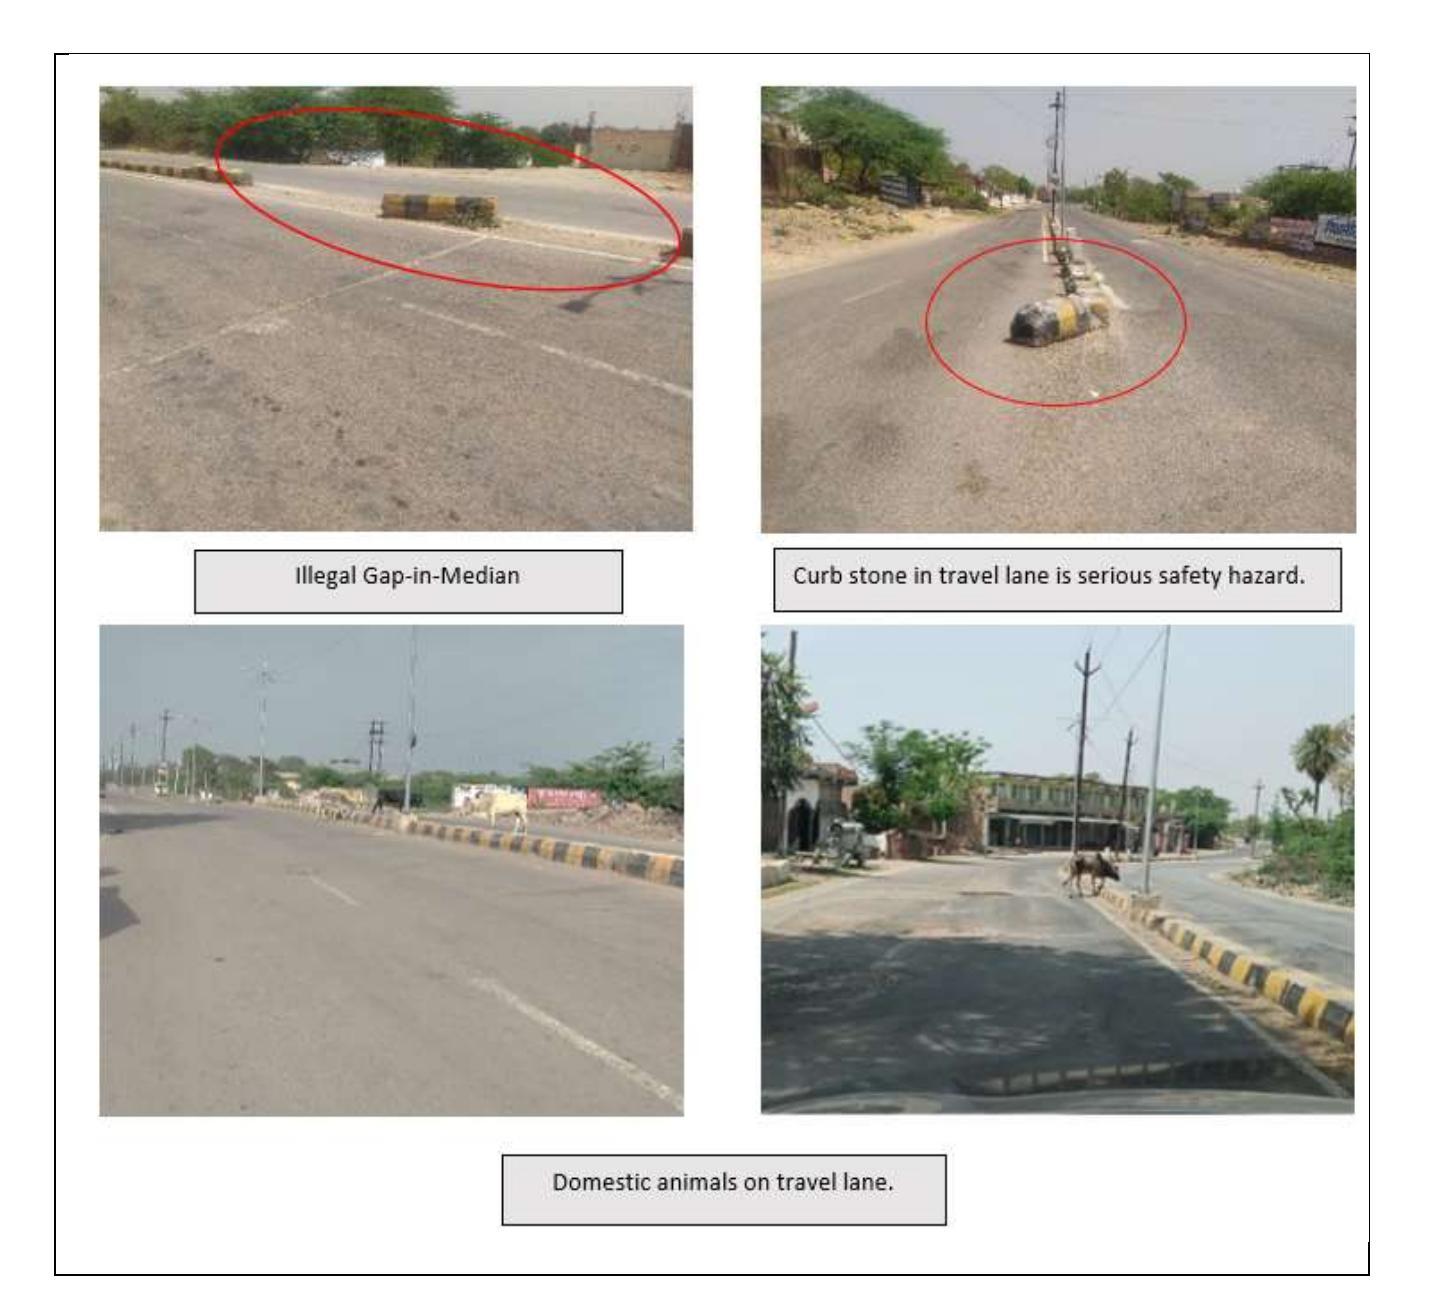
- The divided carriageway on both sides of the corridor has approximately 2 lanes of width.
- Paved shoulder for parking vehicle in case of emergency/breakdown is not available throughout the stretch.
- Carriageway boundary is not clearly defined through curbs.
- Road surface quality is very poor at many locations on the stretch.
- At many locations, kerb stones in median have been removed to create illegal gap-in-medians.
- Domestic animals were noticed on travel lane.

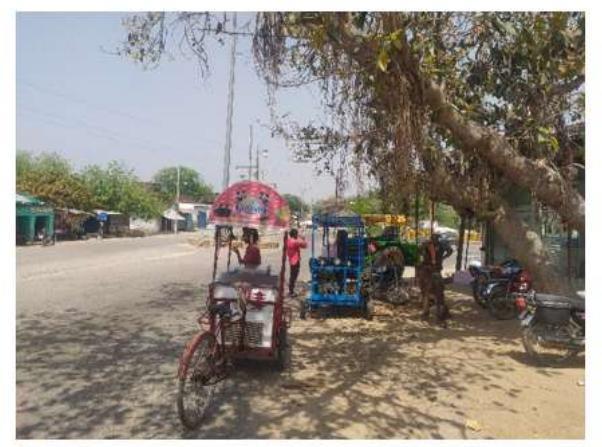
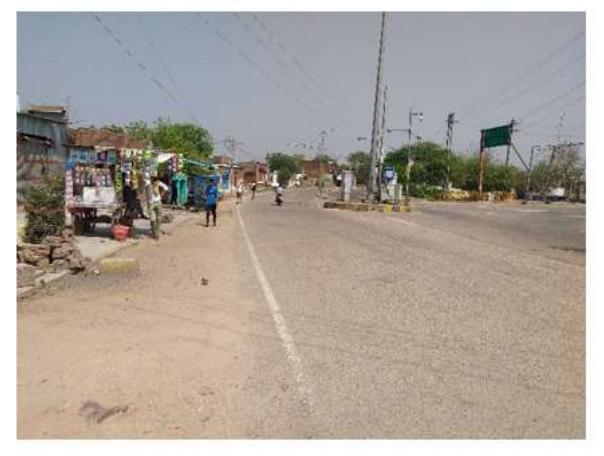
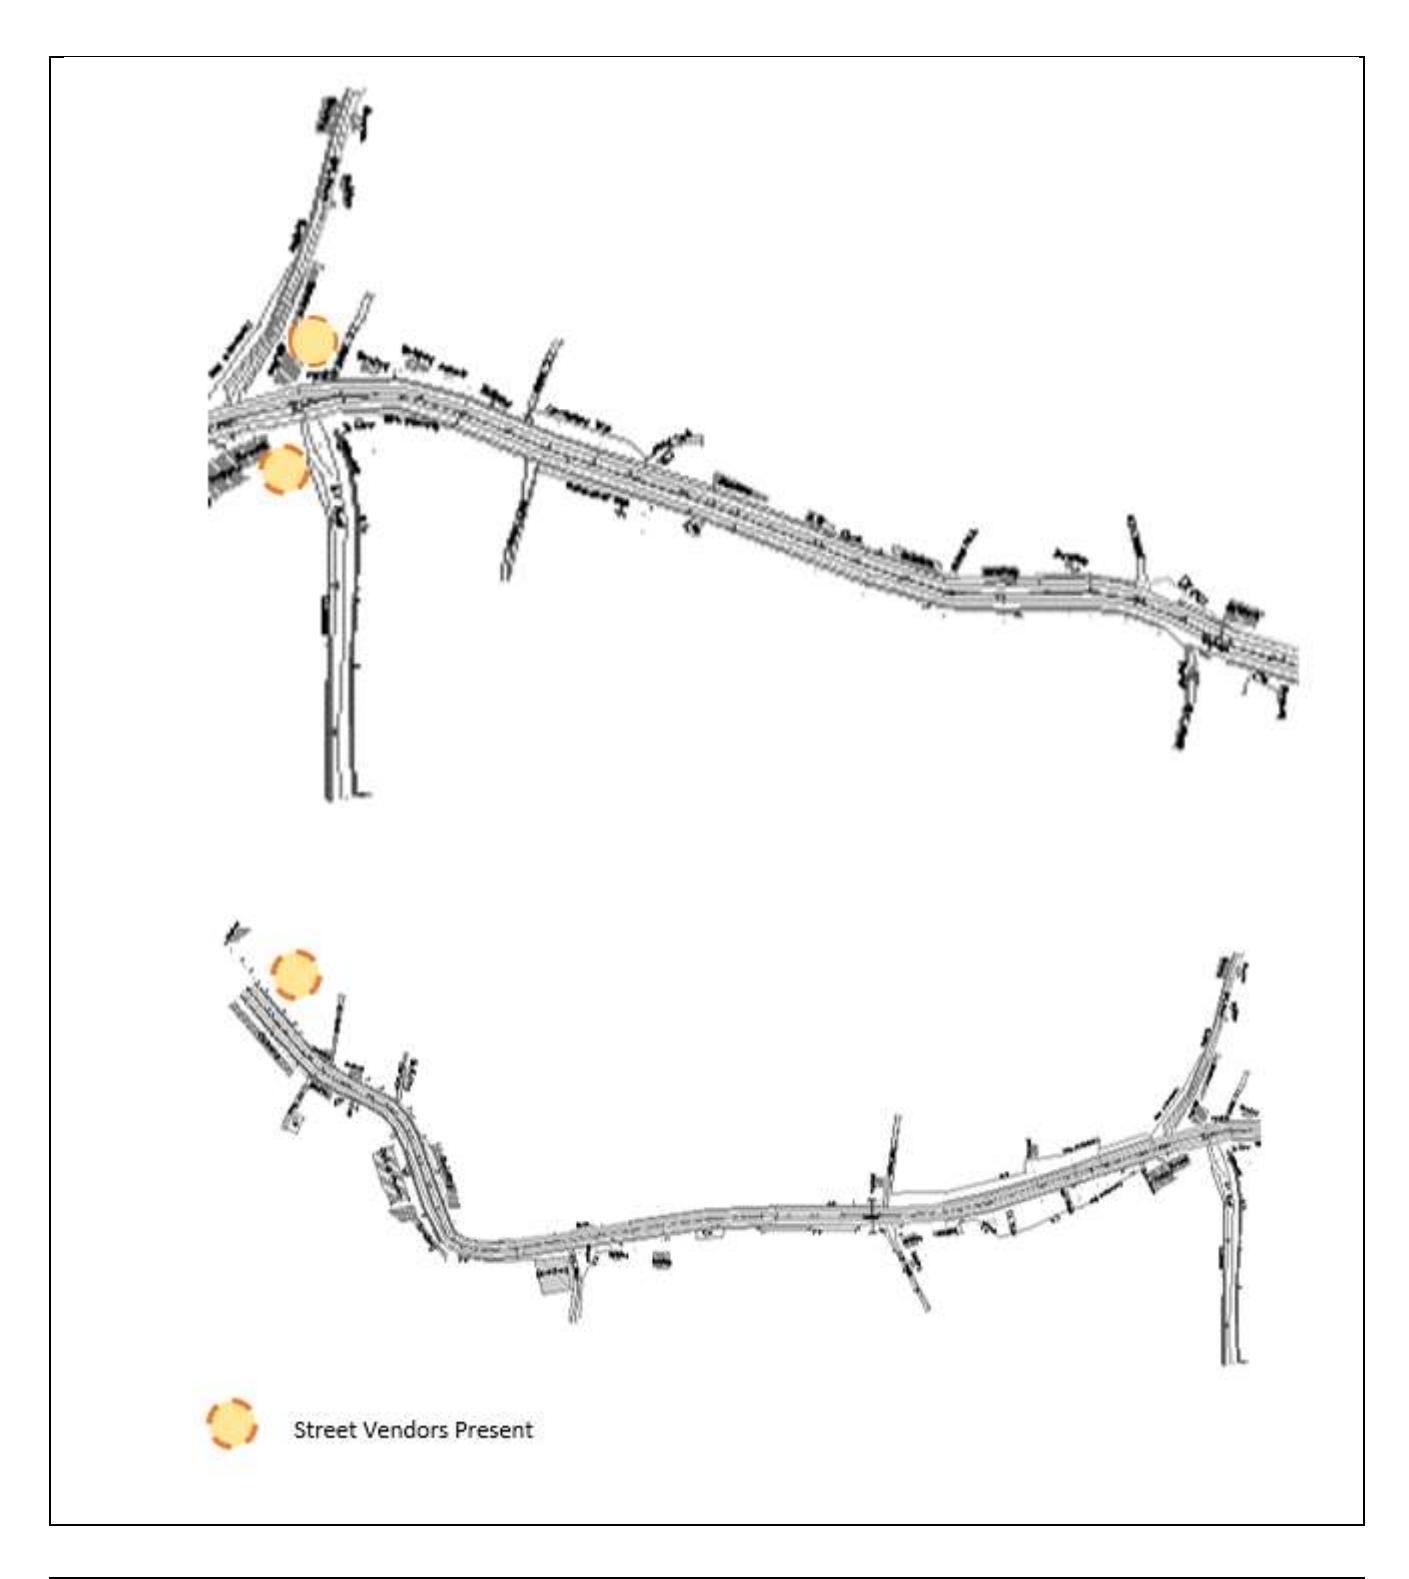
• Street vendors were observed at south end of the stretch and at intersection of Dehat police station.

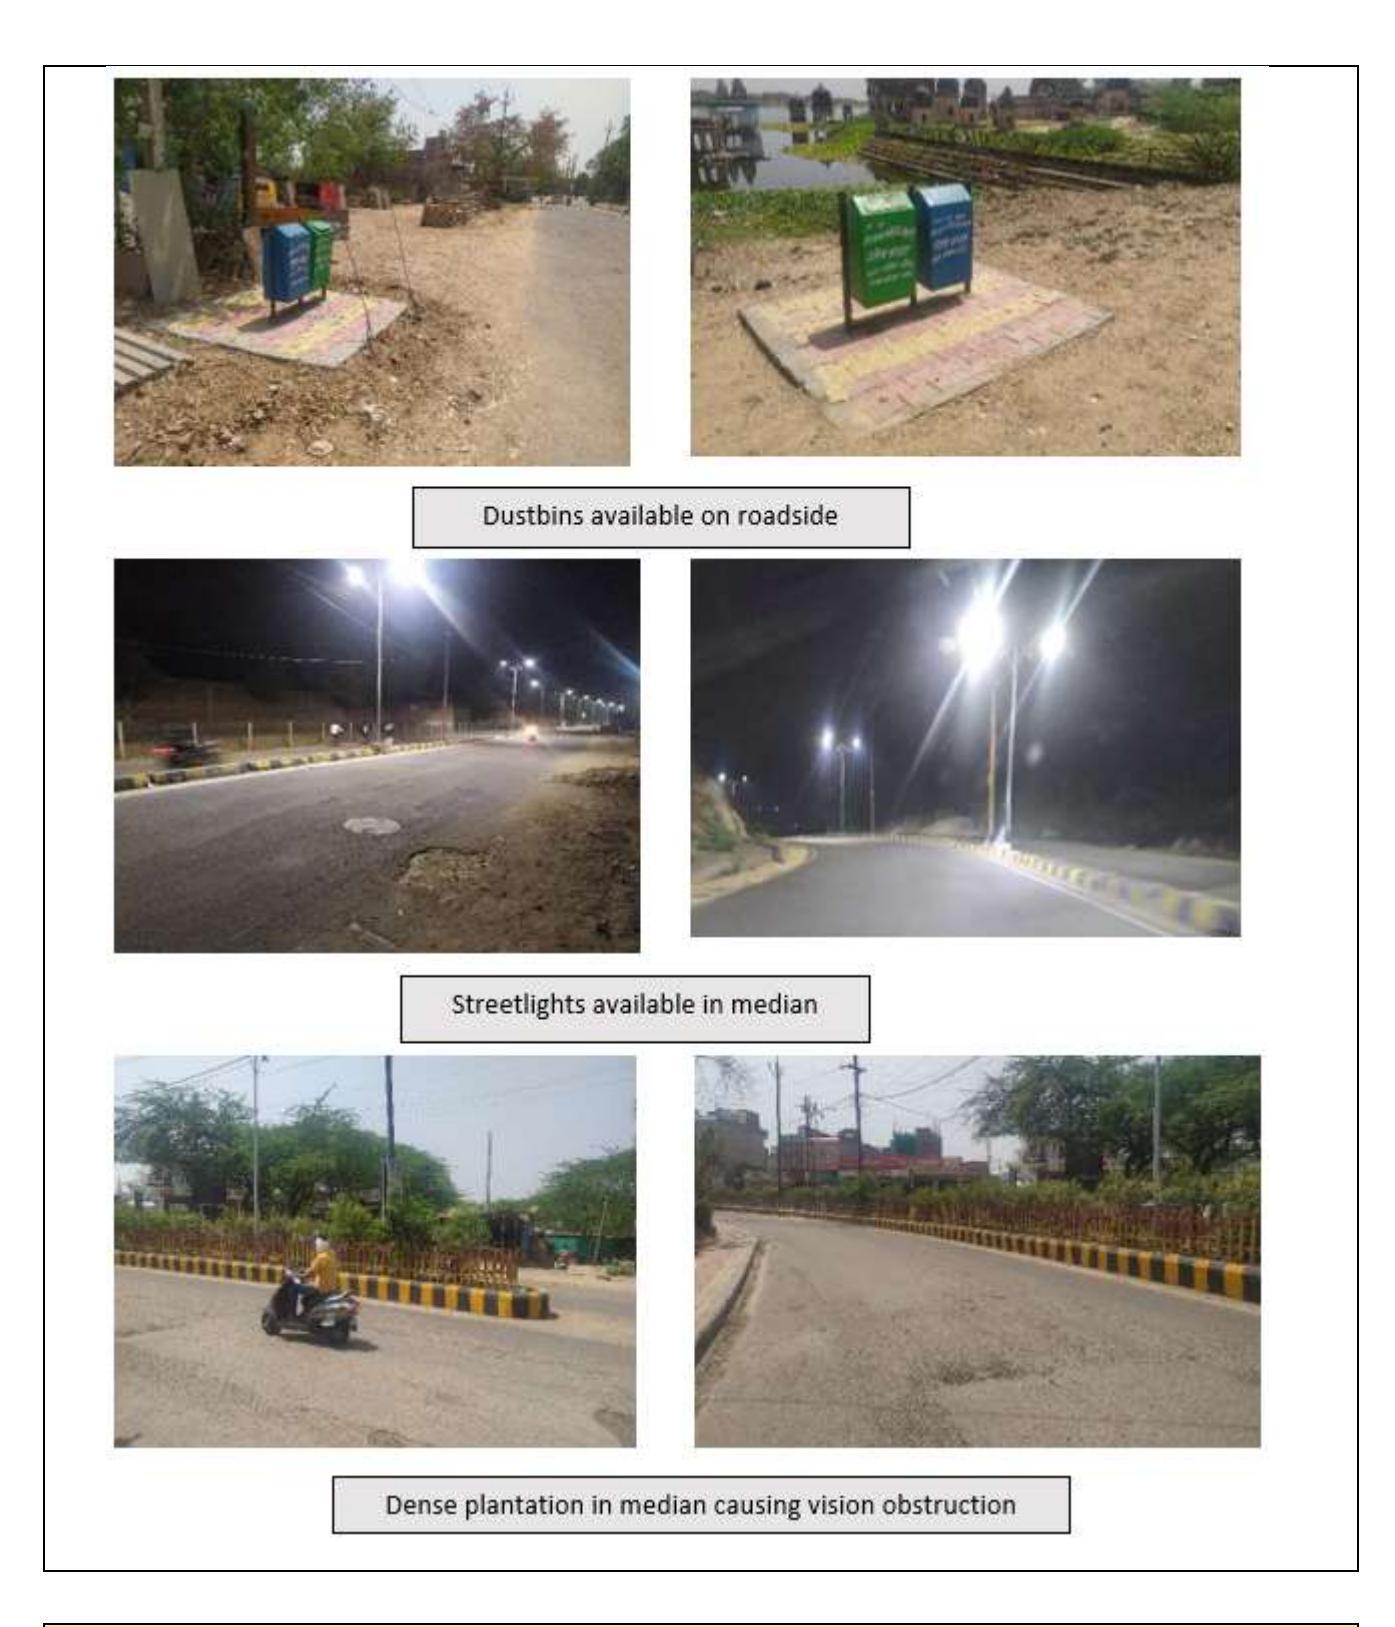
- Dustbins were present at some locations but are not in use by the road users.
- Streetlights were present in the median of the corridor.
- At some locations, vegetation in median is very dense and high, which creates vision obstruction at gap in medians.
- Bollards and railings were not observed throughout the stretch for pedestrian safety.
- Toilets were not observed on the road.

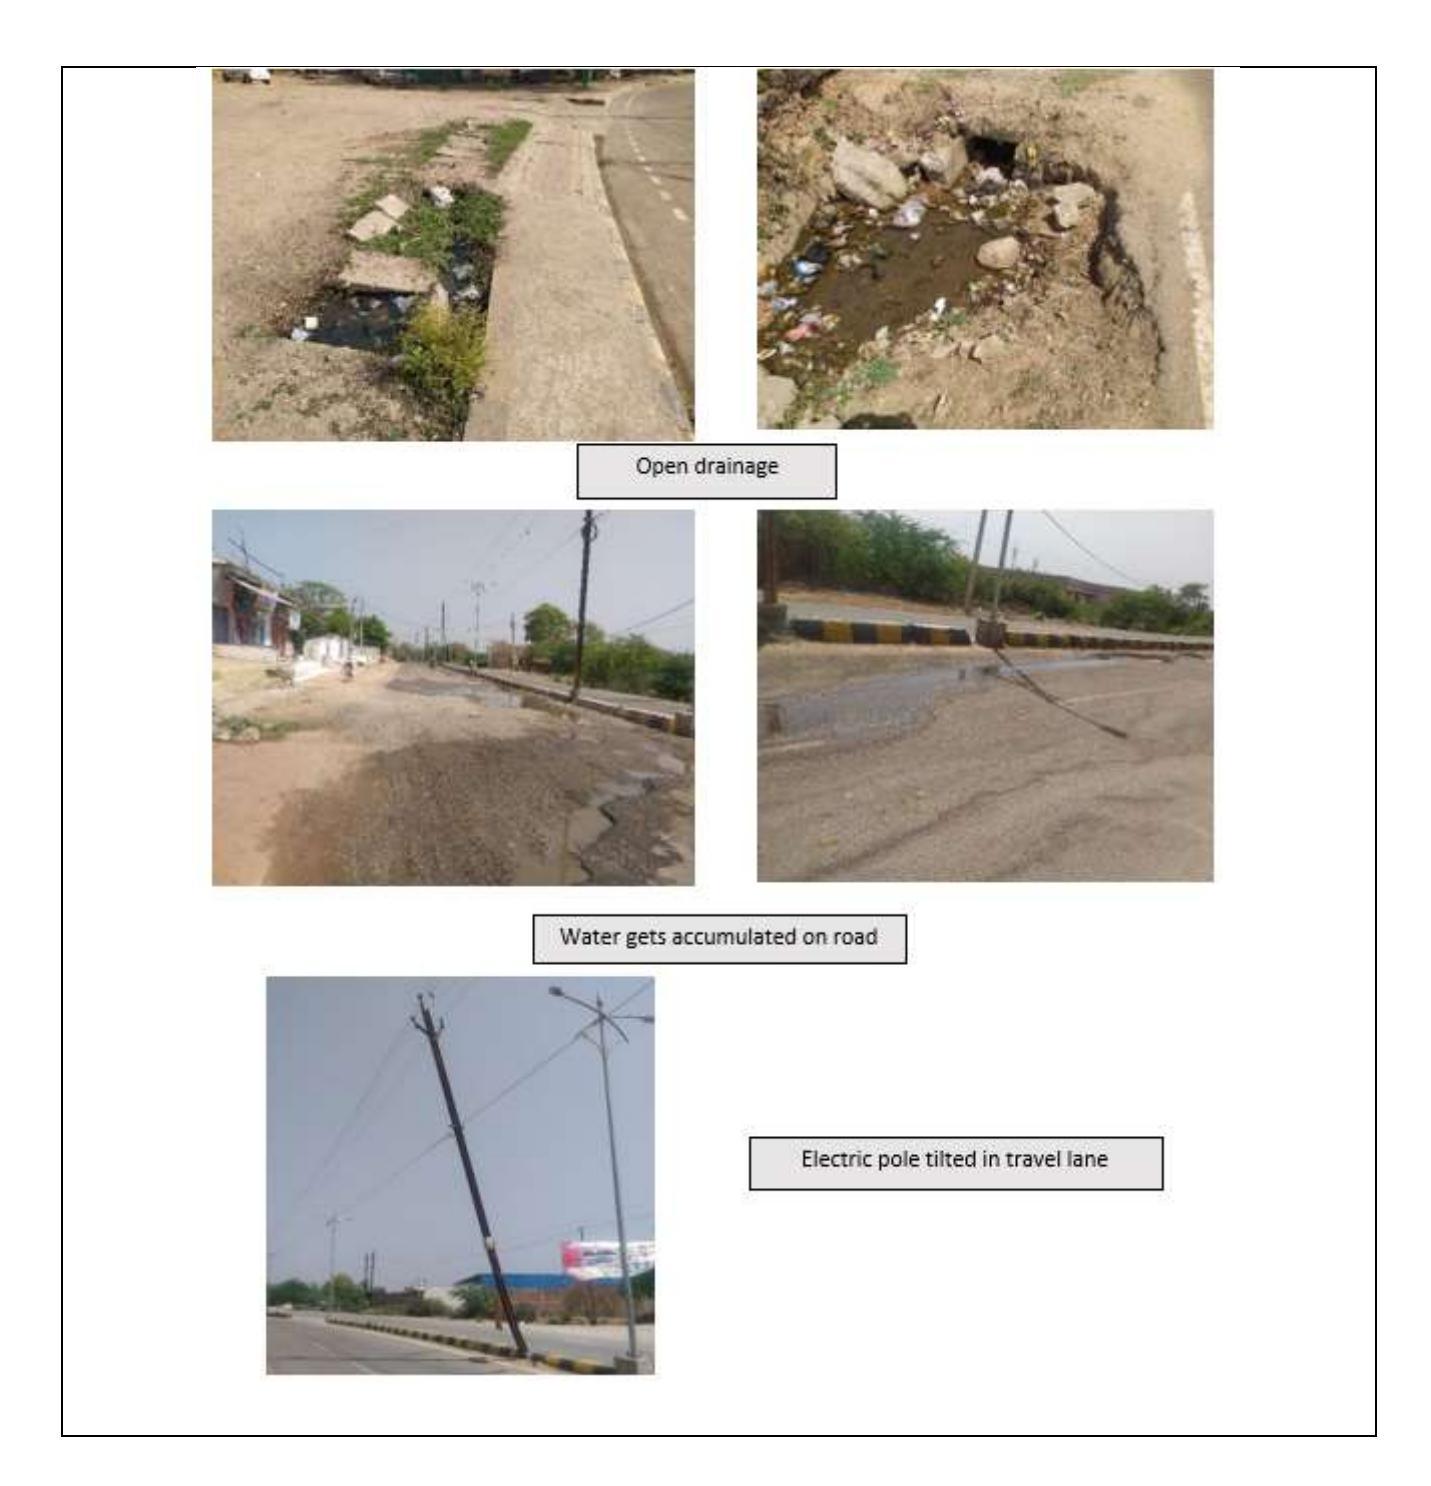
- At some places, presence of open drain was noticed on the side of the road on carriageway going towards north. Carriageway going towards south doesn't have drainage on the roadside.
- At few locations on stretch, water from nearby residential and commercial area travels on road and gets accumulated on road which deteriorates the surface quality of the road and can create road safety hazard for motorcyclists.
- At one location electric pole was tilted and it was projecting inside travel lane.

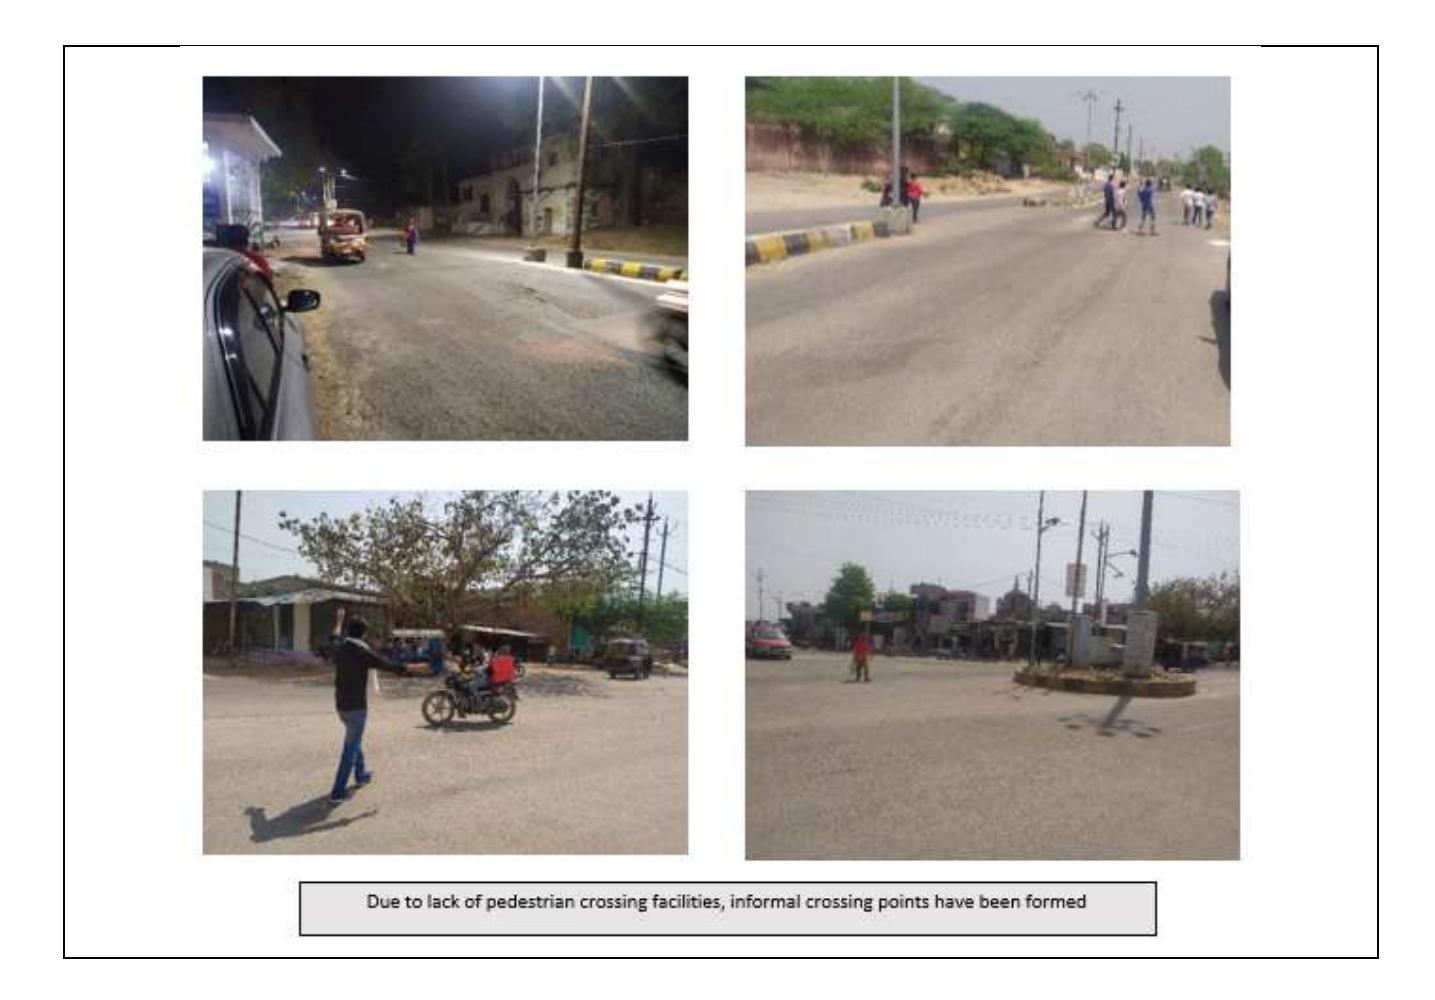
A. Pe	edestrian Crossing
Field (Observations:
•	Pedestrian crossing facilities (such as zebra cross marks, refuge islands, tabletop crossing etc.) are not available throughout the stretch neither at intersection nor at midblock.
٠	Informal crossing points are created at some locations which are used by pedestrians.

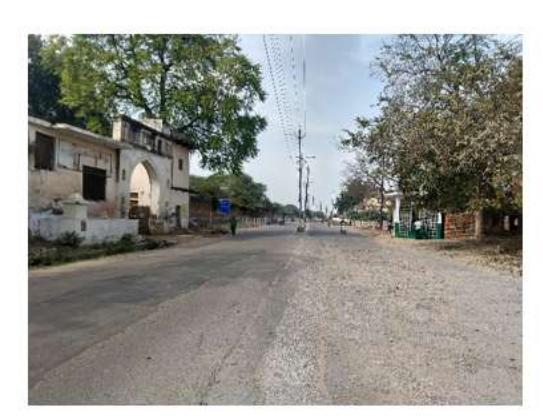
No Signage for the intersection.

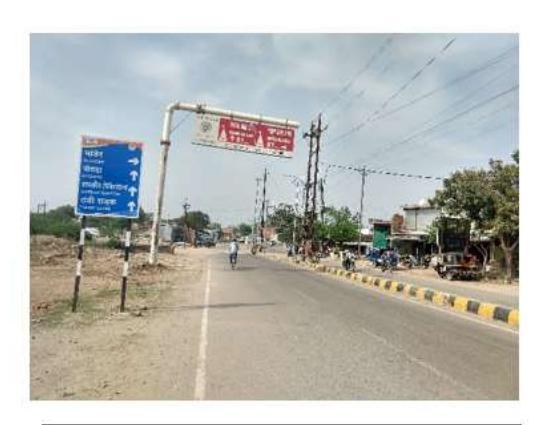
Information signage available on the road, intersection.
